Overhead Transmission Structure and Foundation Asset Management – Inspection & Structural Retrofits

Kento Arai (SDG&E®) & Jonathan Jordan, P.E. (EDM International)

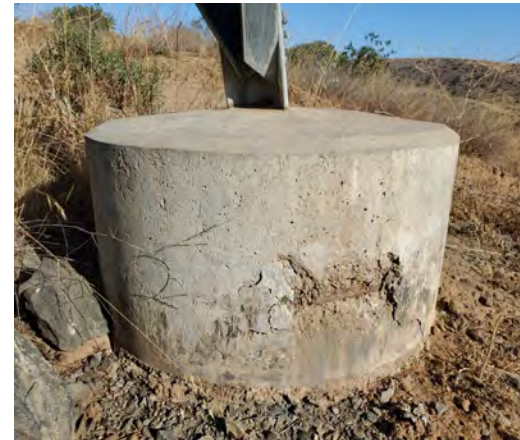
Cracked Pier

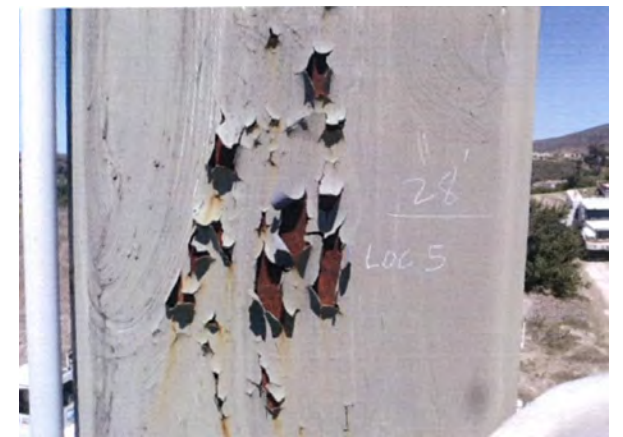
Damaged Coating

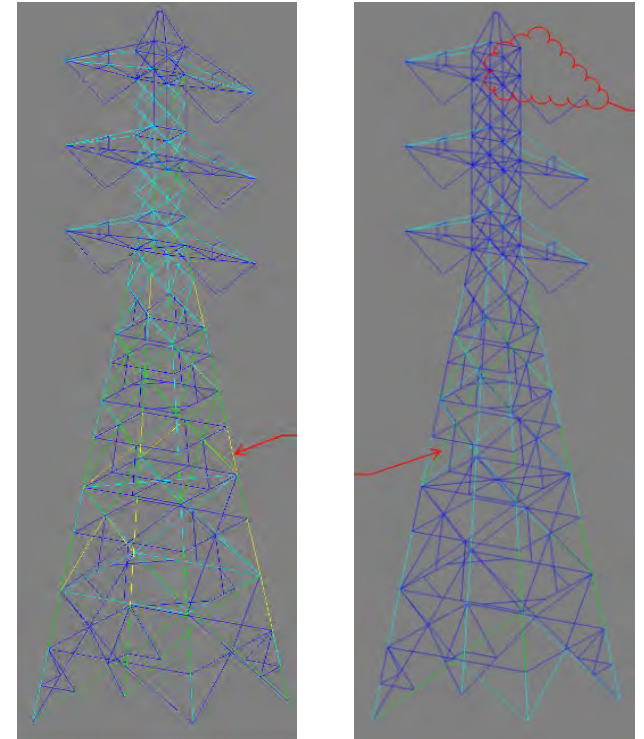
Weld Analysis for Repair

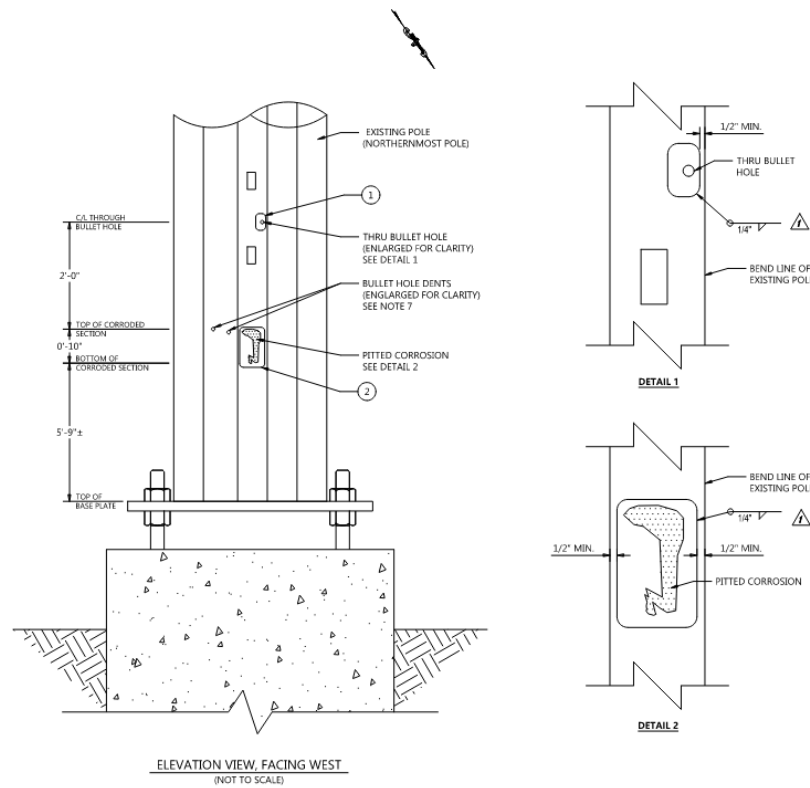
Solution Example #2 – Welded Repair for Corroded Steel Section

7. BULLET HOLE DENTS TO BE REPAIRED USING FIELD PLUG WELDS TO FILL DENTS. DENTS MUST BE FILLED WITH WELD UP TO SURFACE OF POLE AND GROUND SMOOTH ON SURFACE.

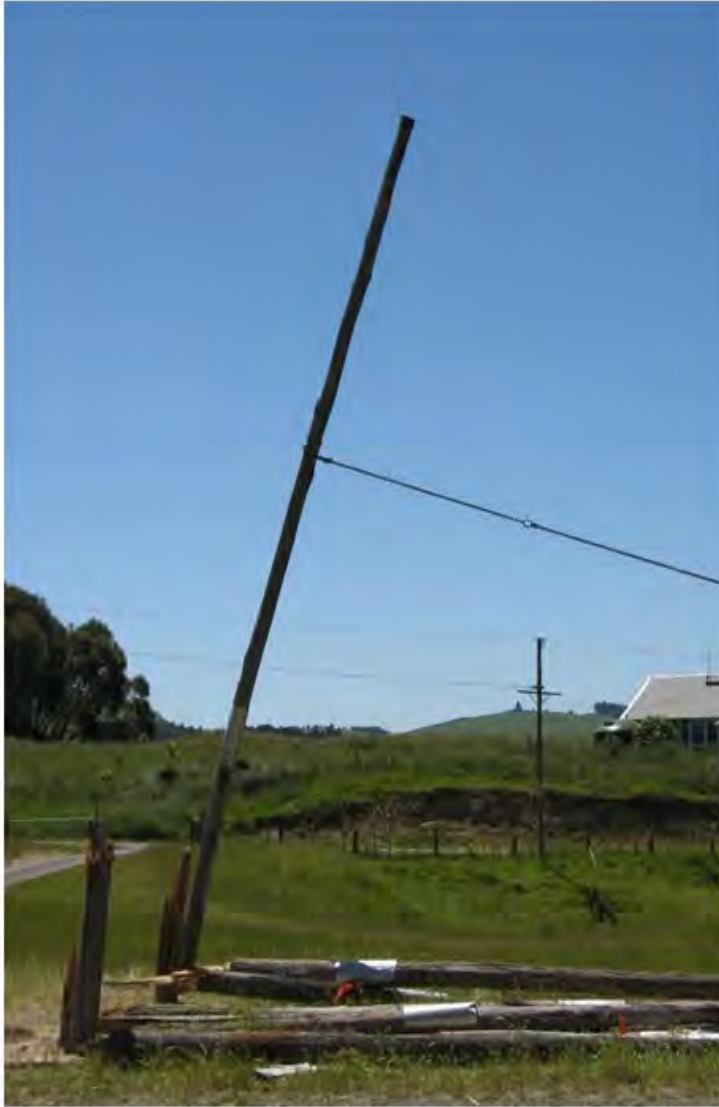
Photo 17: Pole 135134 at failure.

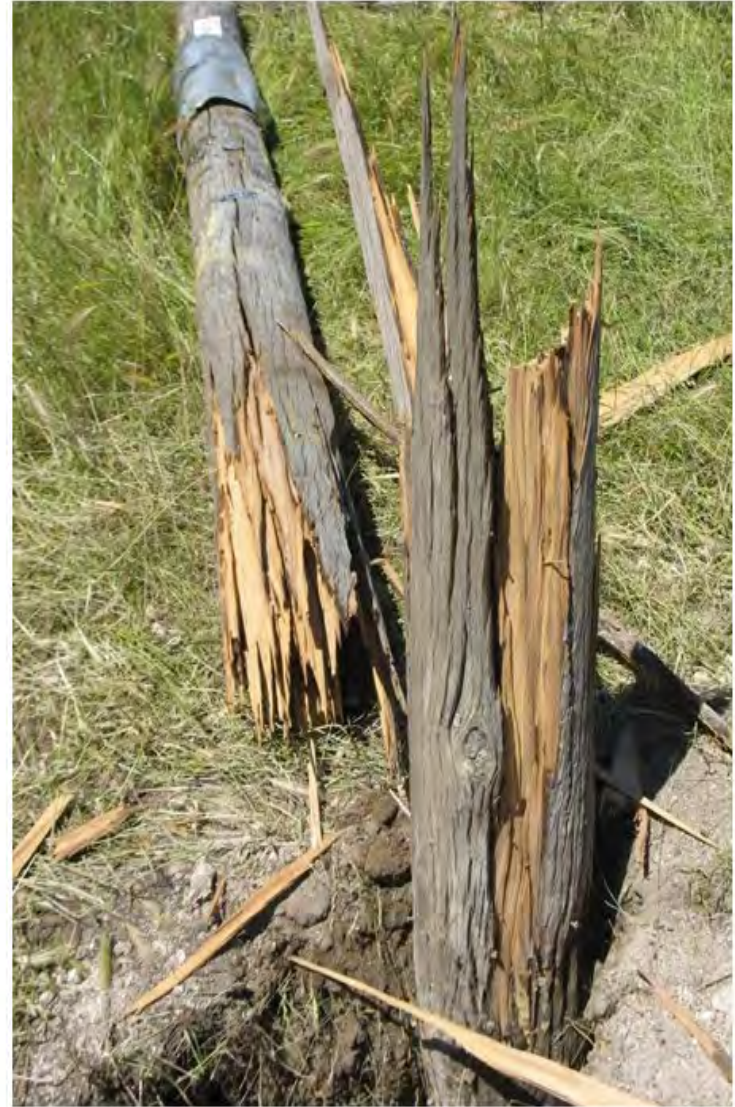
Photo 18: Fracture in base section of Pole 135134.

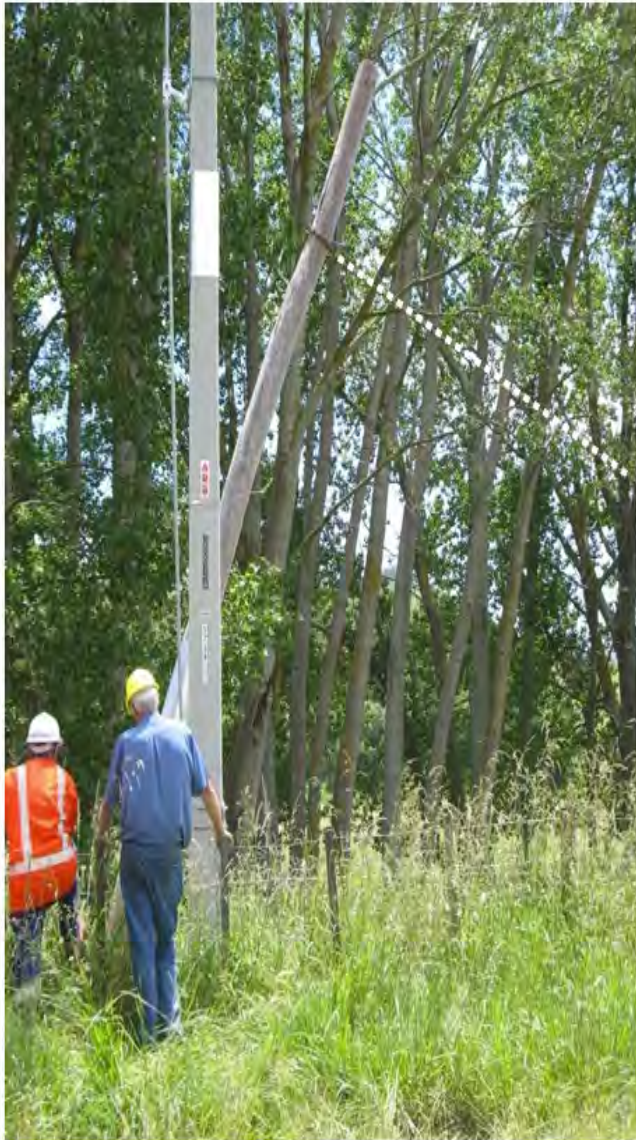
Photo 23: Pole 125668 at failure. Chain highlighted.

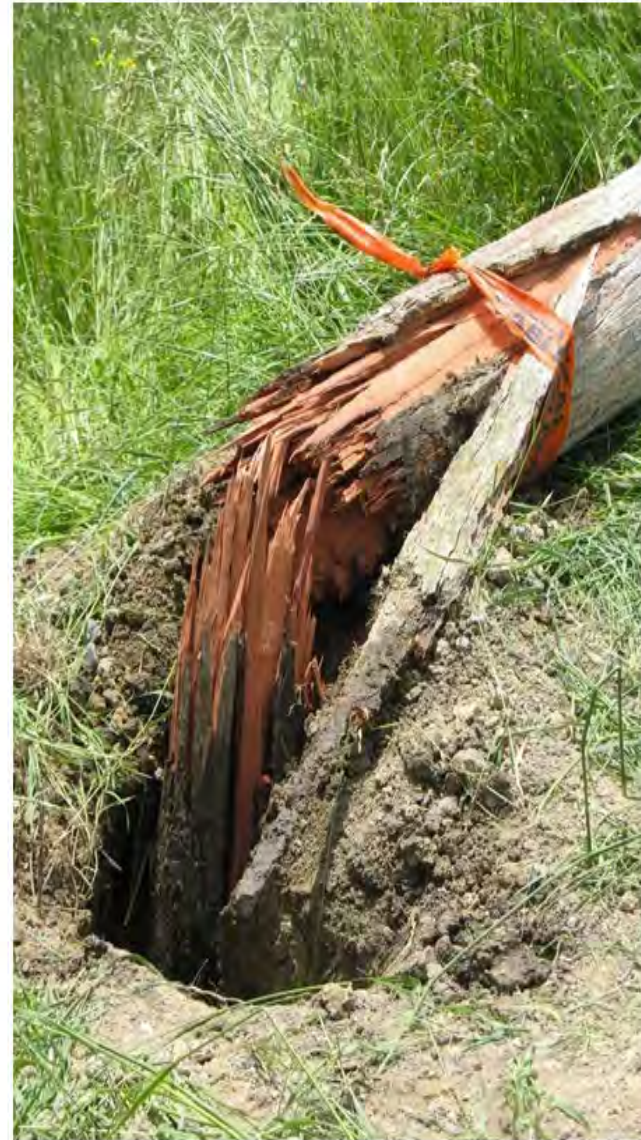
Photo 24: Fracture in base section of Pole 125668.

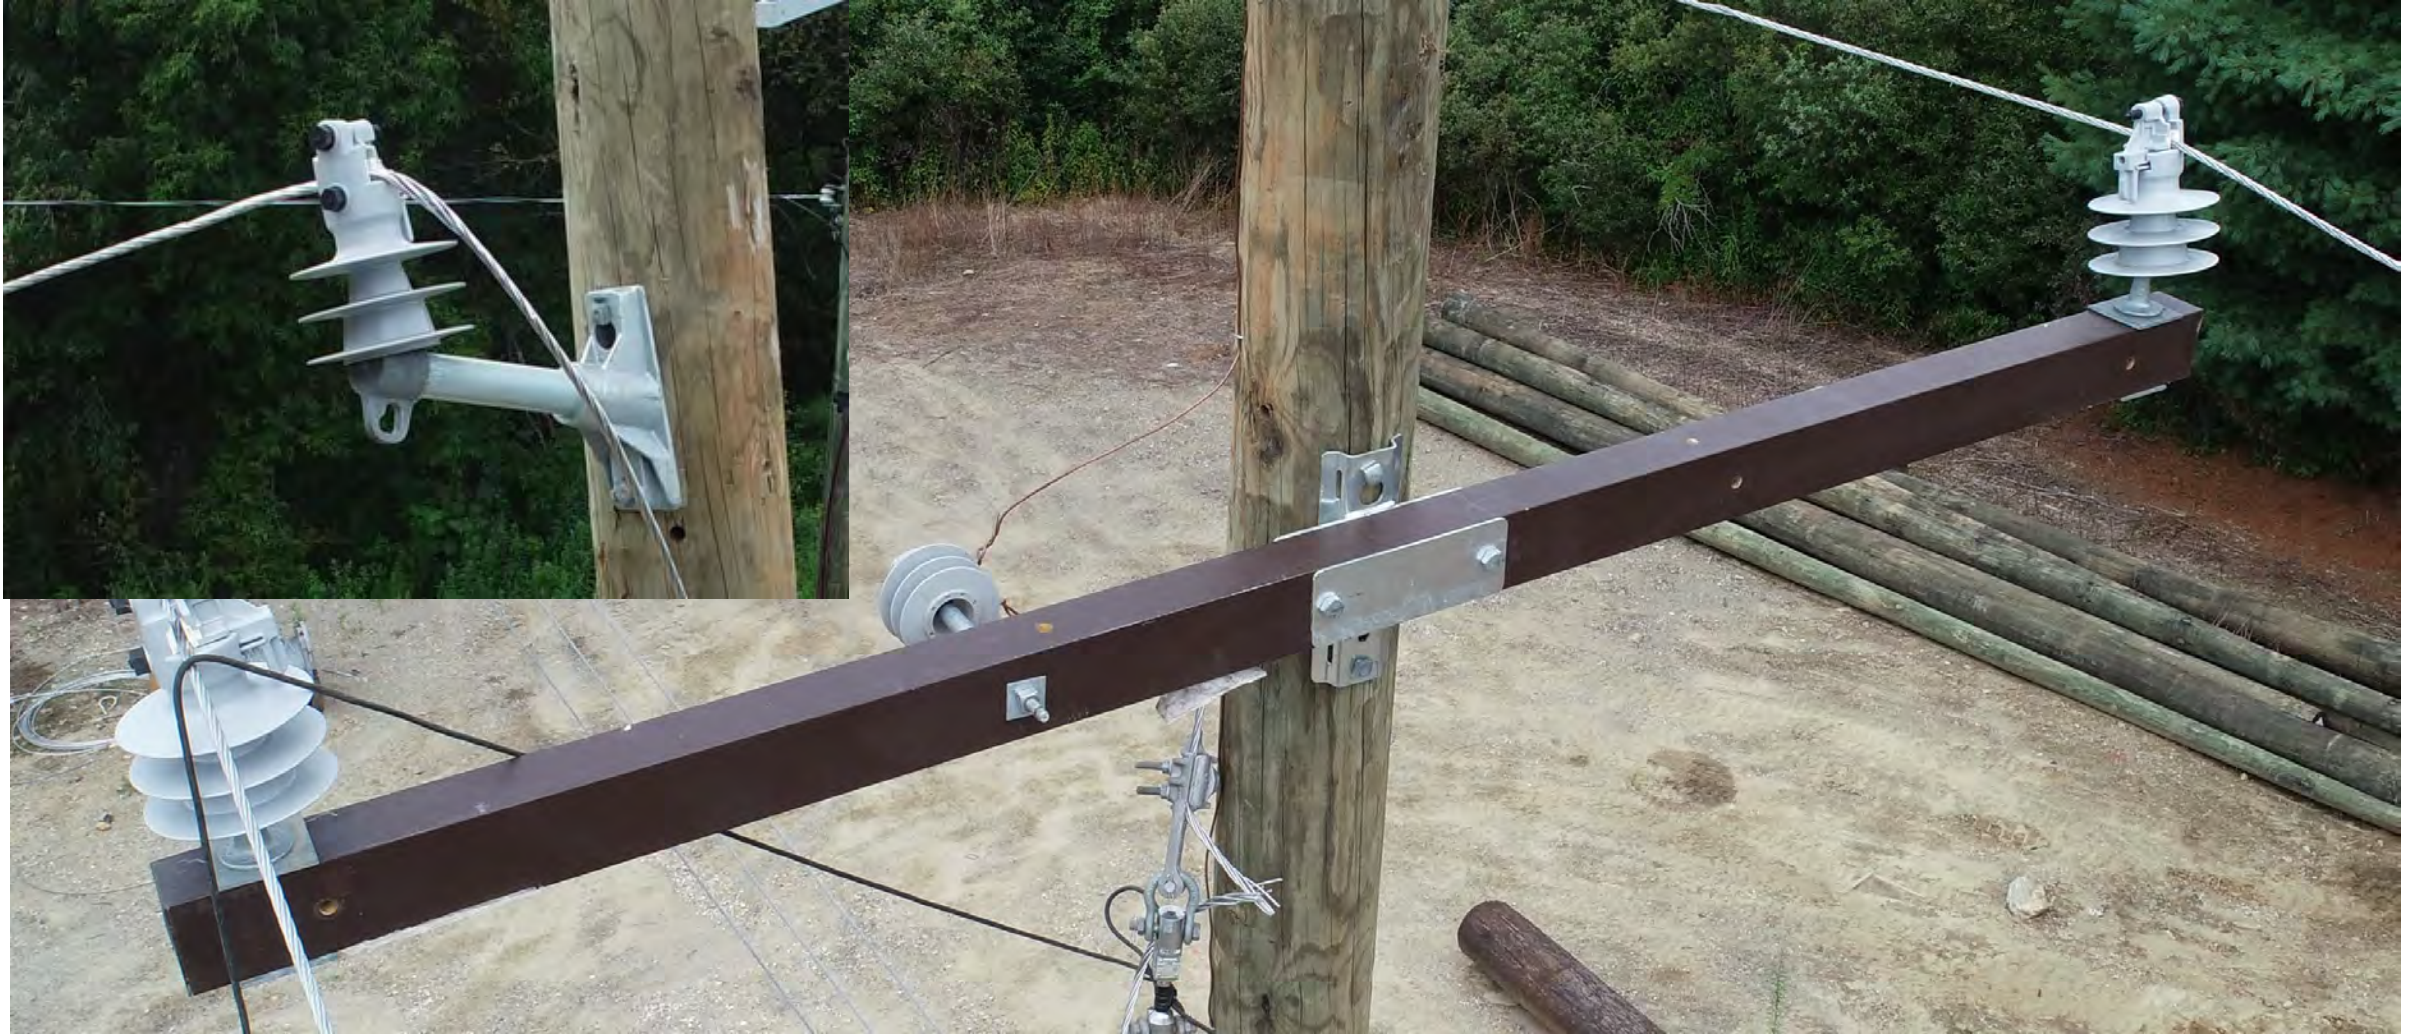
No damage sustained to crossarm or arm, wires captured

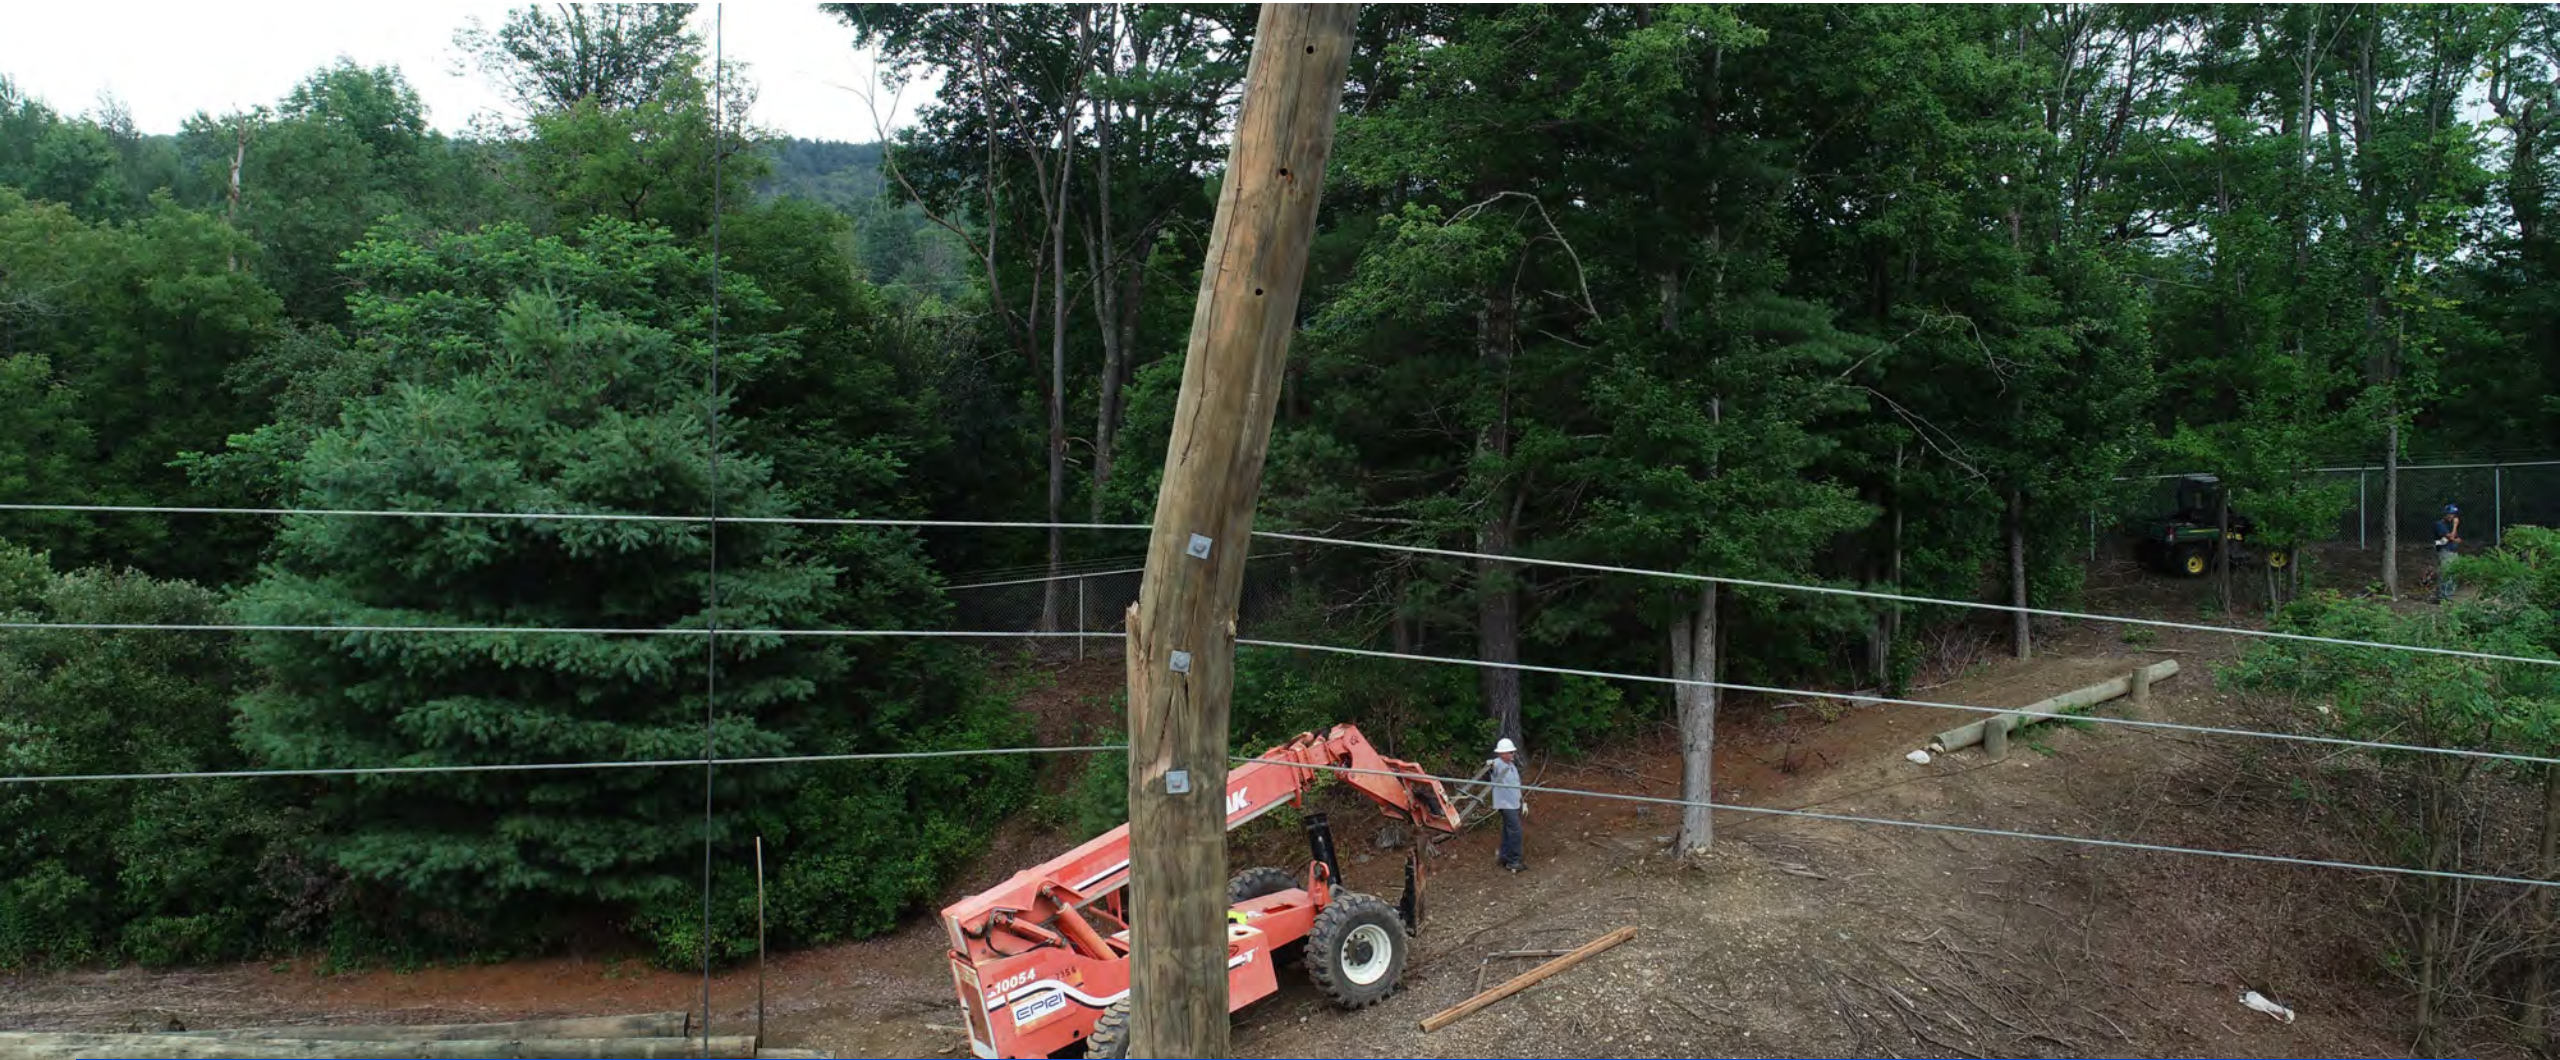
Increasing vise-top clamping force decreases slip, increasing pole break risk
