The long-term value of Alassisted virtual inspections

2024 INTERNATIONAL OVERHEAD LINE CONFERENCE

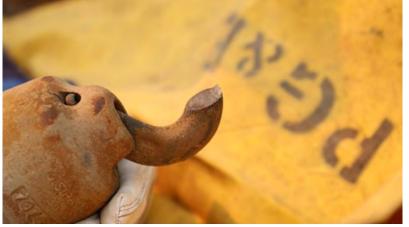
97year hook fractured due to fatigue

A broken hook on the line sparked the fire

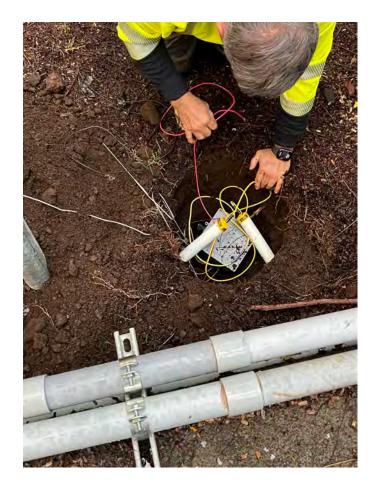
- Matergenics Installed Remote Sensor
- Remote Sensor monitored
 - Environmental temperature
 - Ground temperature
 - Electrochemical potentials (to estimate ground corrosion activities)

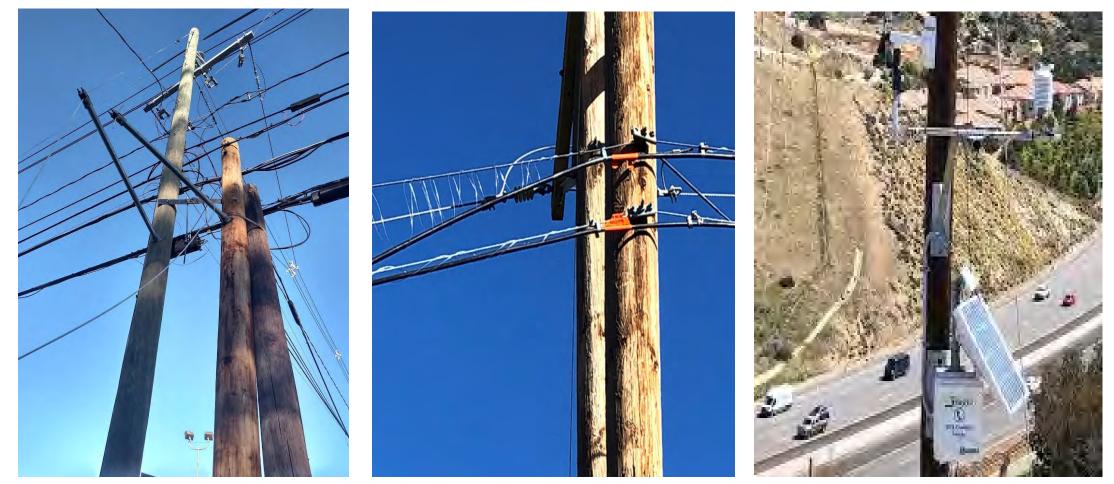
Buddy Poles

Comm. cables w/broken lashing
