Overhead Transmission Structure and Foundation Asset Management – Inspection & Structural Retrofits

Kento Arai (SDG&E®) & Jonathan Jordan, P.E. (EDM International)

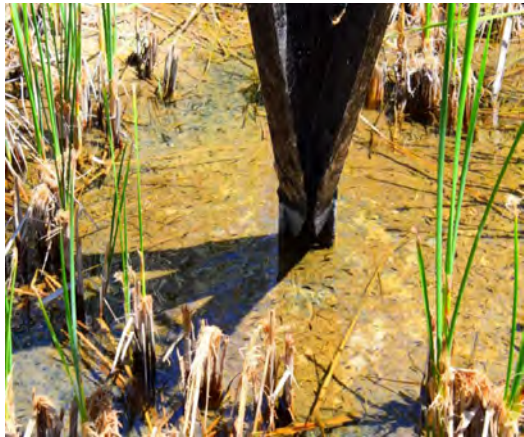
Submerged Pier and Stub Angle
