EDM

Evaluating the Effectiveness of the TransGard Laser System at Substations in Indiana and Louisiana

Ashley Bennett, PhD, EPRI
James Dwyer, PhD, EDM International
Rick Harness, EDM International
Yamille del Valle, PhD, EPRI
American Electric Power
Entergy

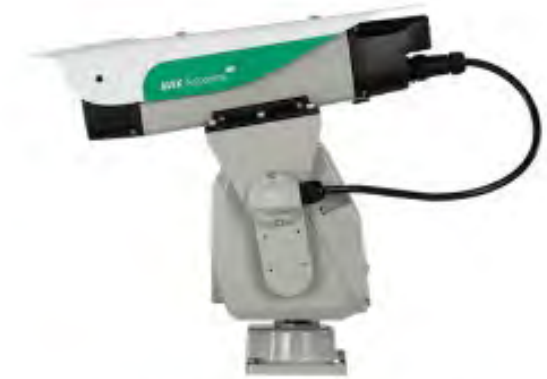
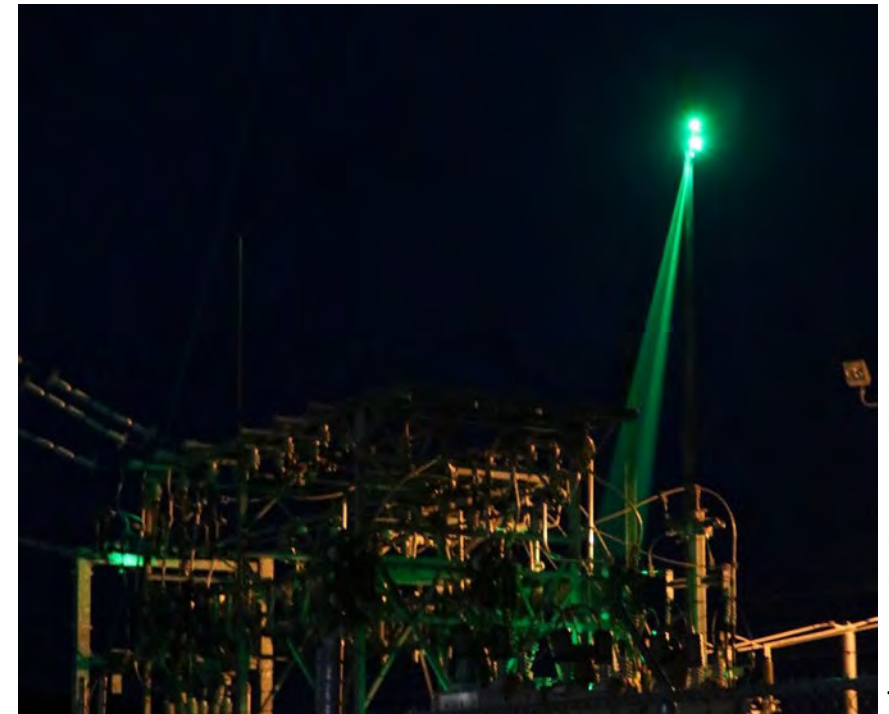
PROGRAMMABLE MOUNTED LASER

- Alternative Solution - Lasers
 - TransGard programmable mounted laser
 - Laser Bird Defense System (LBDS)
- How does it work?
 - Birds disperse from approaching laser beam
- TransGard described benefits
 - Low cost
 - Easy to deploy
 - Humane and low impact
 - Autonomous with custom programmed laser paths across substation
 - No habituation
 - Prevents nesting and roosting

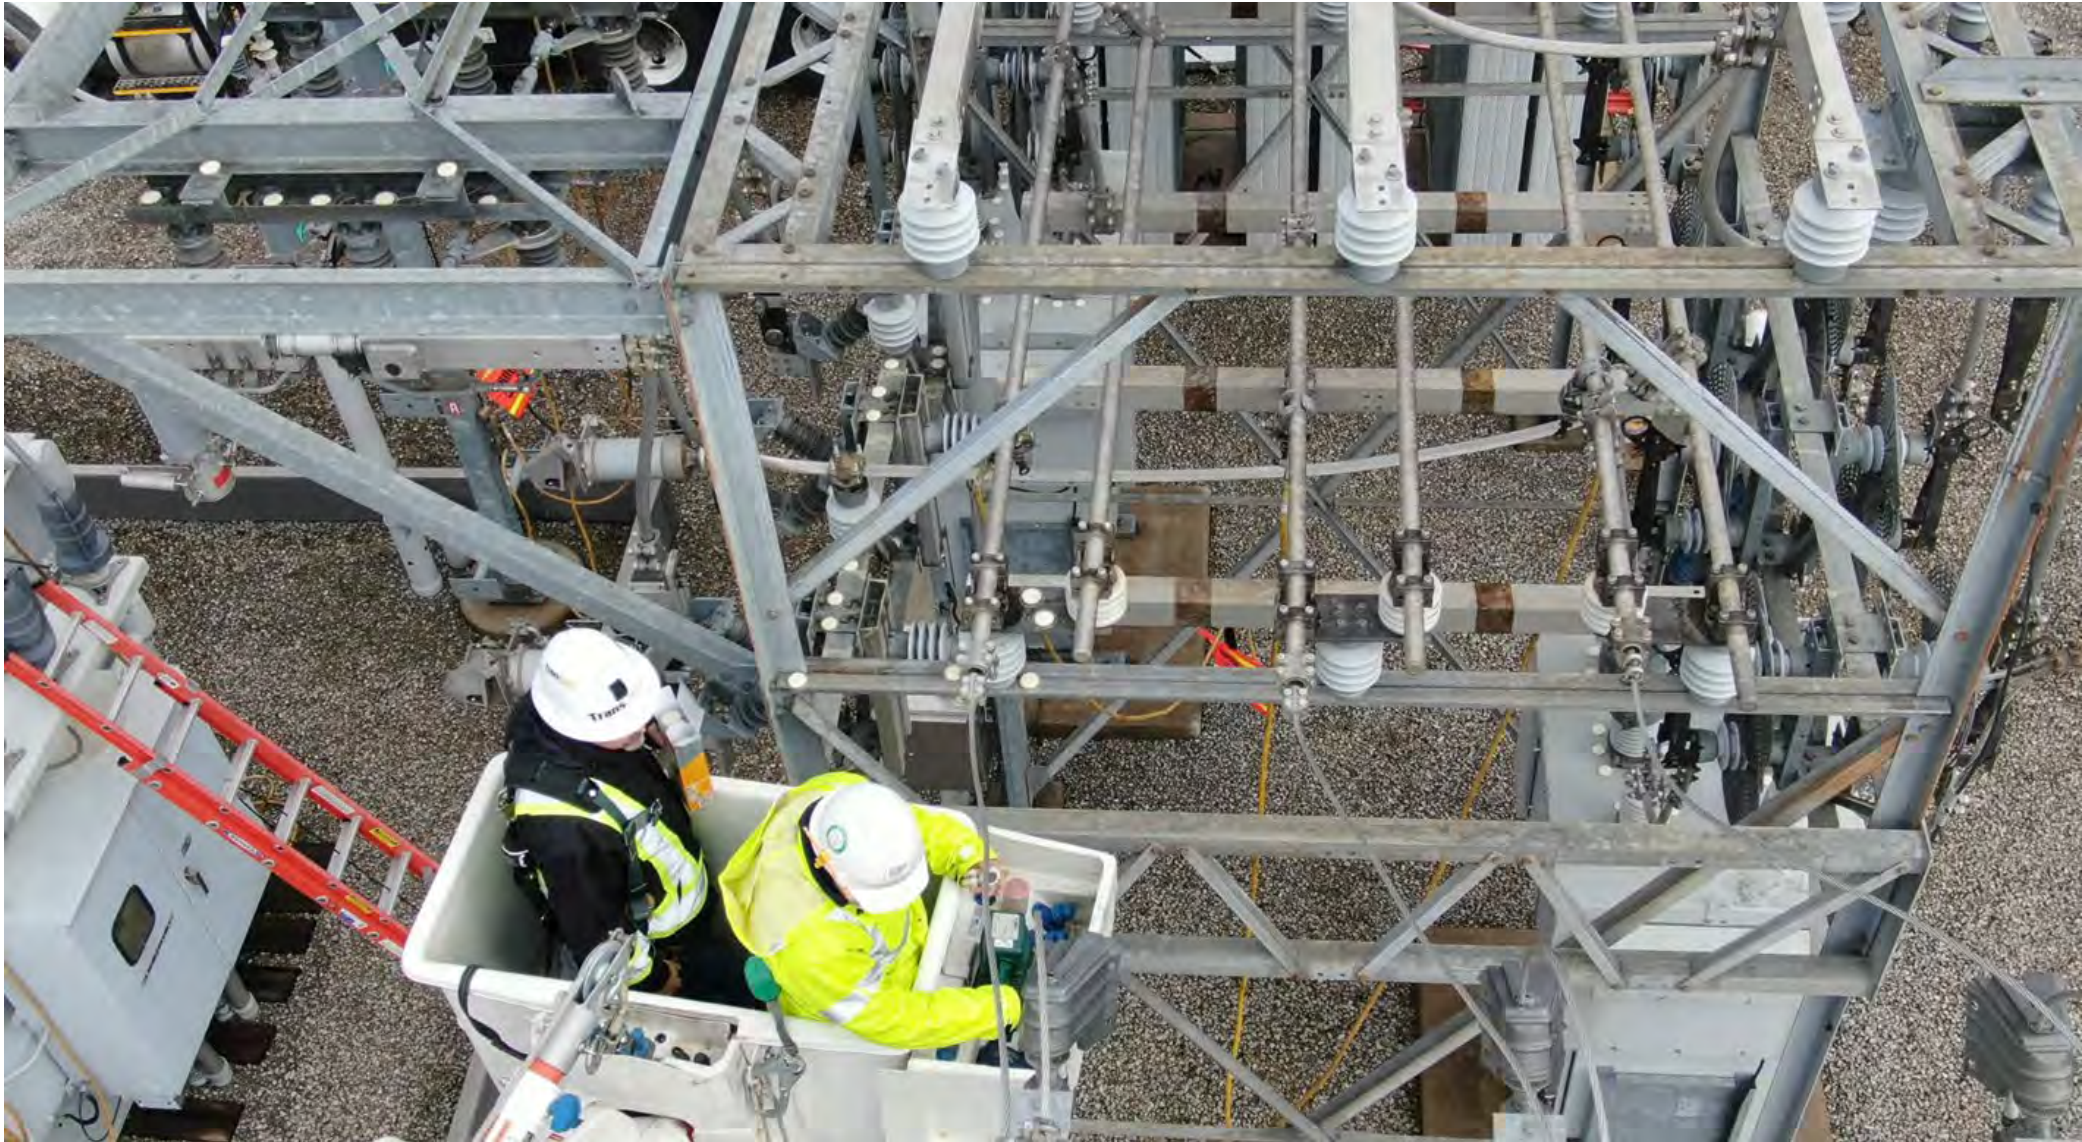
Study 1 – Installation of Optical Gel Disks

* Gel disks are used to complement the lasers serving as a physical deterrent & placed in areas nesting is expected

- Installation methodology followed TransGard recommendations
 1. Site preparation
 - Removed all existing nests
 - Solvent and pressure washing targeted low-side rack to remove soiling
 2. Placement of optical gel disks
 - Serves as nesting deterrents complementing lasers
 - Placement of gel disks targeted
 - Horizontal surfaces throughout the low-side rack
 - Substation transformer
 - High-side rack
 3. Selection and programming of lasers and laser routes
 - Performed by TransGard
 4. Laser was operational

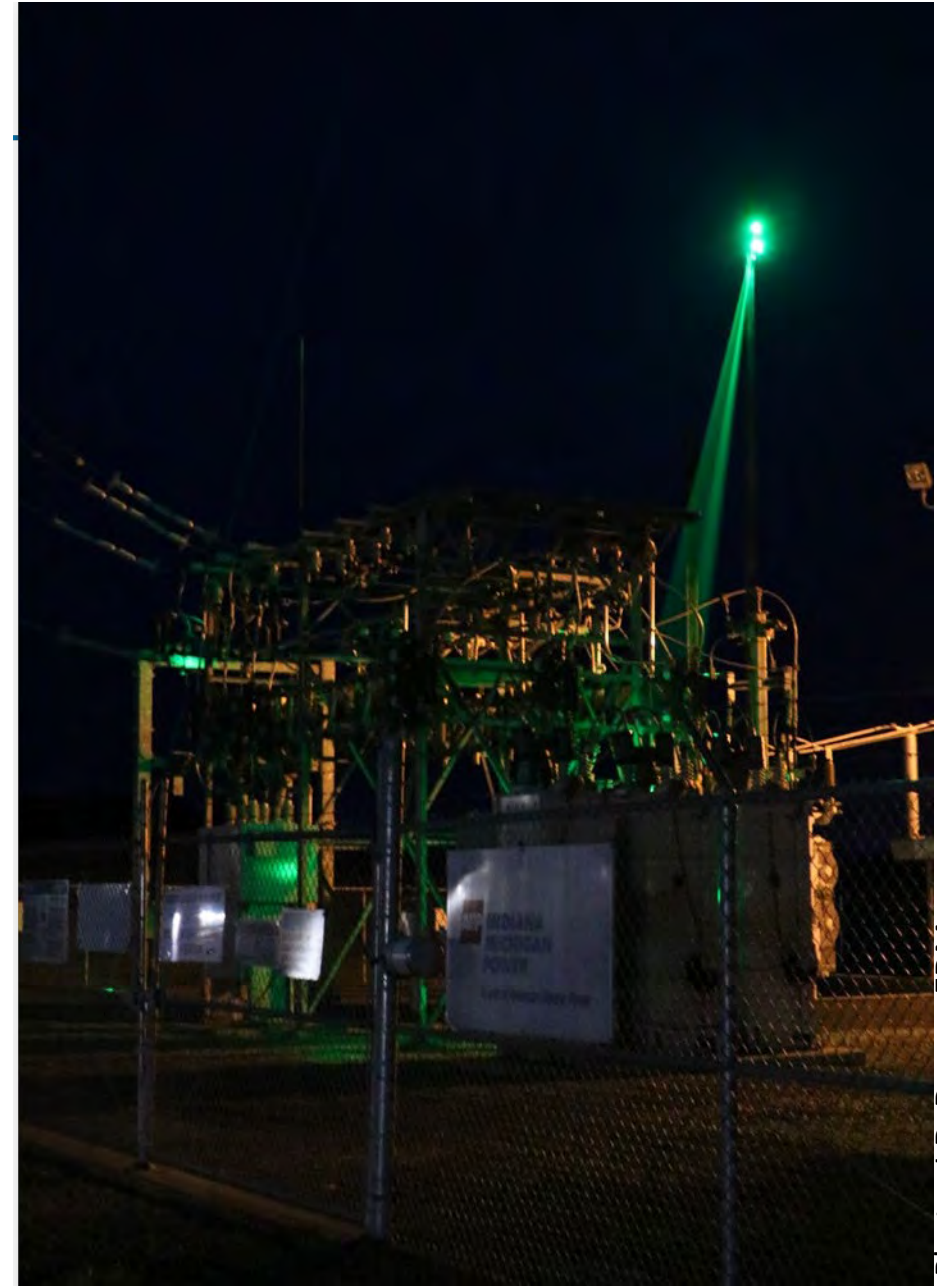
Study 1 – Study Design

- Demonstration with 1 study site
- Bird nesting and bird activity was compared before and after laser activation
- Laser effectiveness was assessed for low-side rack
 - Lasers were focused on low-side rack
 - 2 Lasers on daily from 4am – 10pm
 - March – September
 - Laser activation preceded start of nesting season for most birds

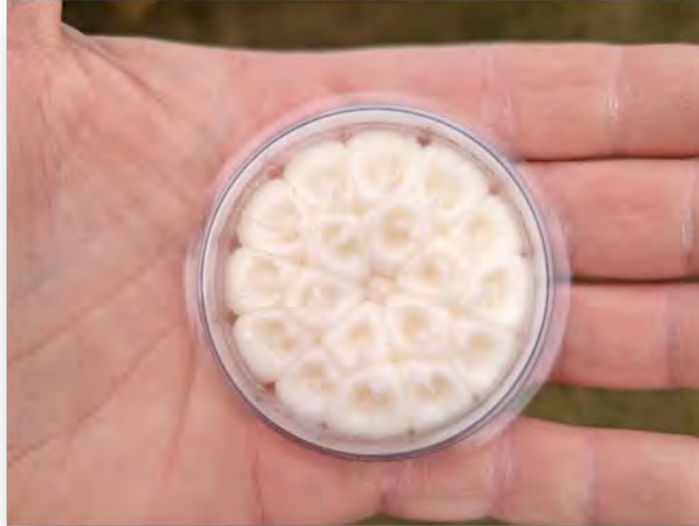
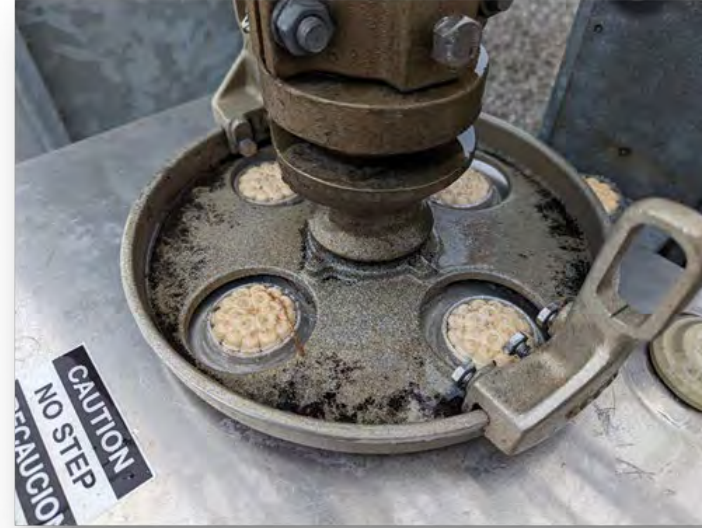
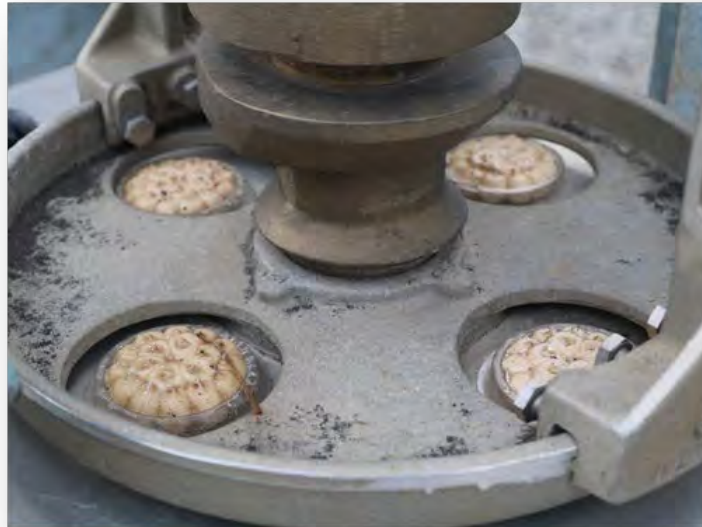
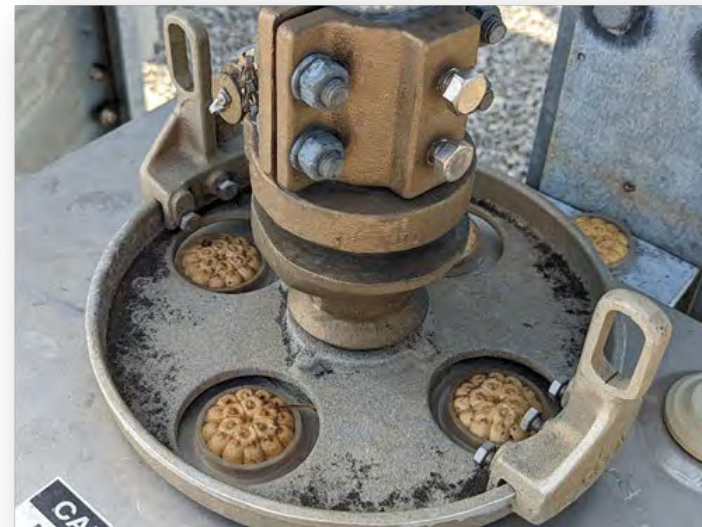
➤ Gel disks over course of study

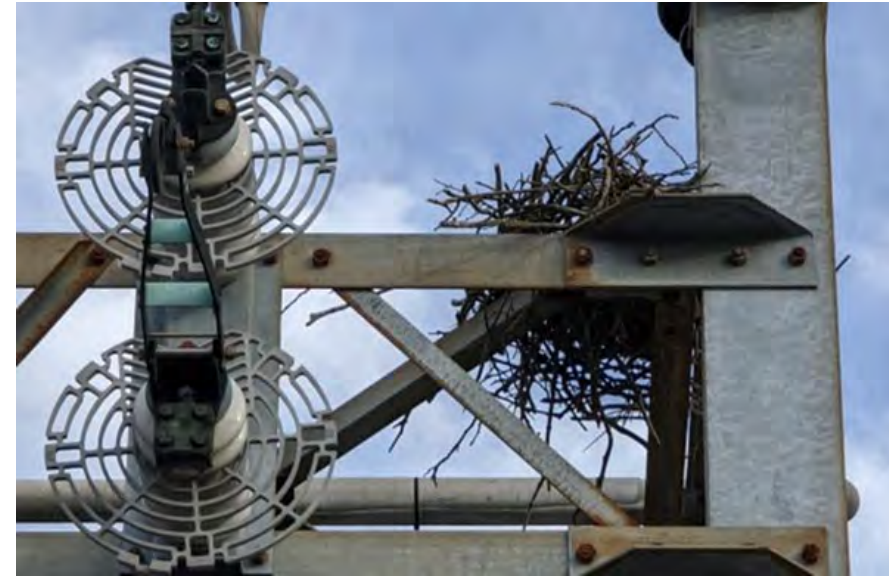
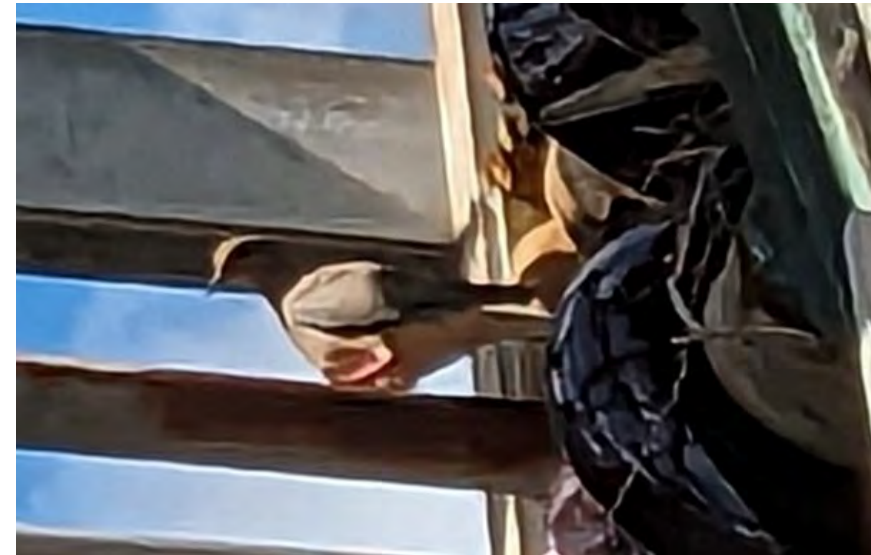
- Data collections
 - Monthly Oct – Dec 2022; Feb – August 2023
- **Nest counts**
 - Substation inspected for nests
- **Avian point counts**
 - 2 timed counts each 3 minutes
- **Site visit counts**
 - Duration of site visit
 - All birds seen or heard were recorded
- Remote cameras
 - 2 trail cameras in each substation
 - Purpose: capture bird activity outside site visits
- Data analysis
 - Model selection focused on point counts, site visit counts, nests

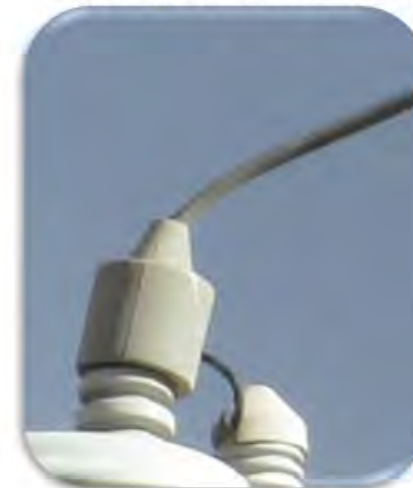
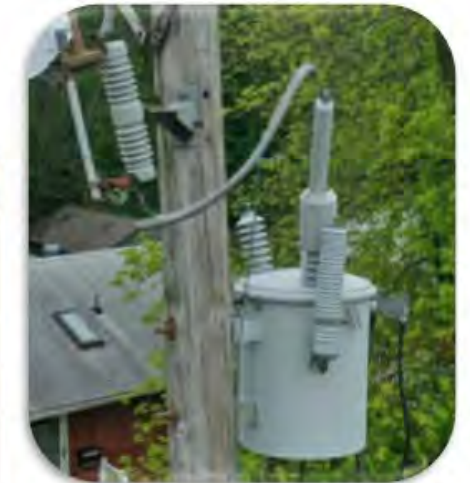
Figure 17. Incorrect – line hose is not fully installed on the tap wire leaving energized gaps

Figure 16. Correct installation

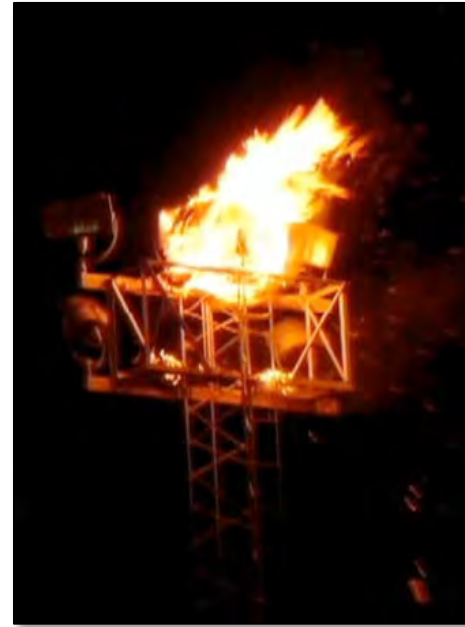
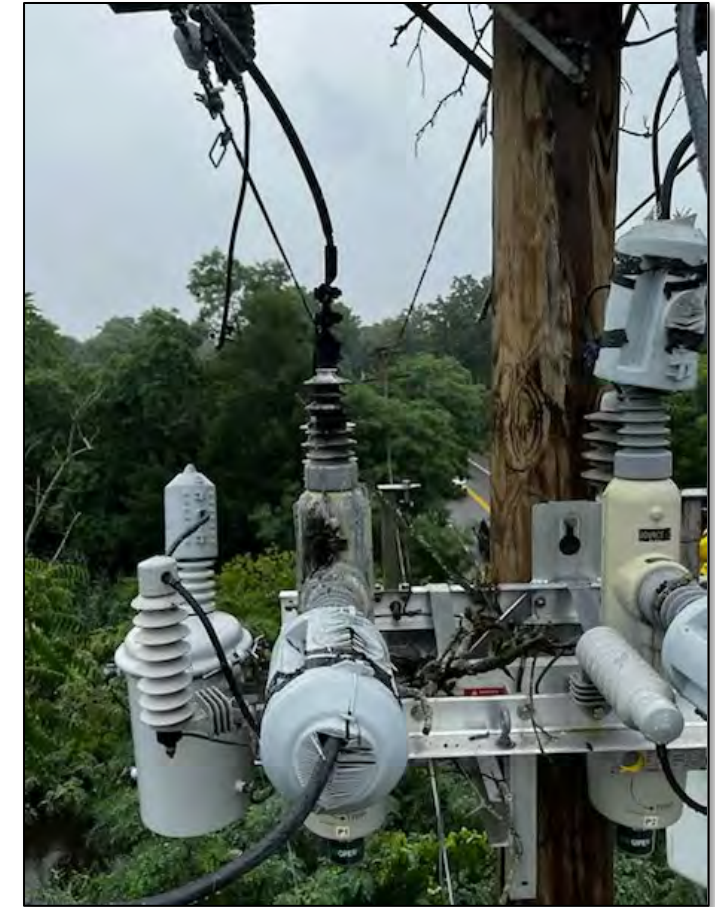
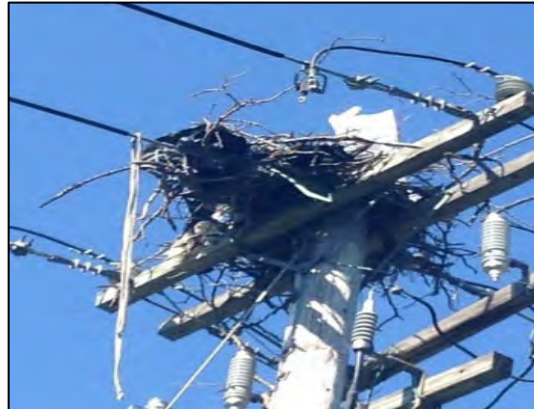
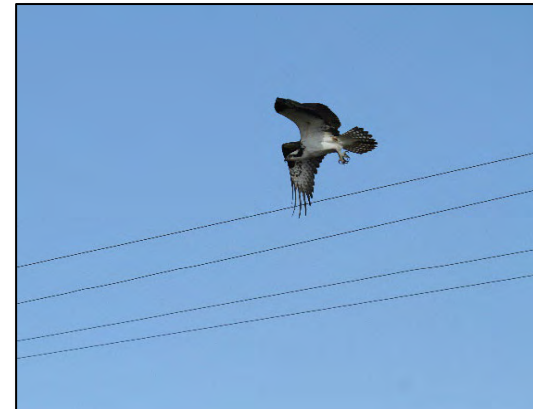
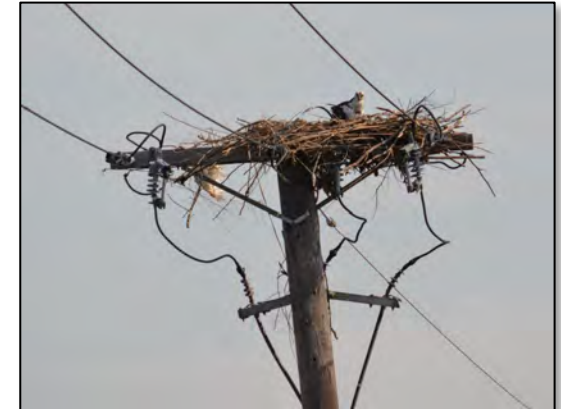
Distribution – Osprey Nesting

Distribution poles are susceptible to bird nesting. Impacts reliability and birds and their young can be harmed.

- Nests on poles can result in line trips and fires
- Birds can be harmed by fire, electrocution & collisions
- Highly visible to the public

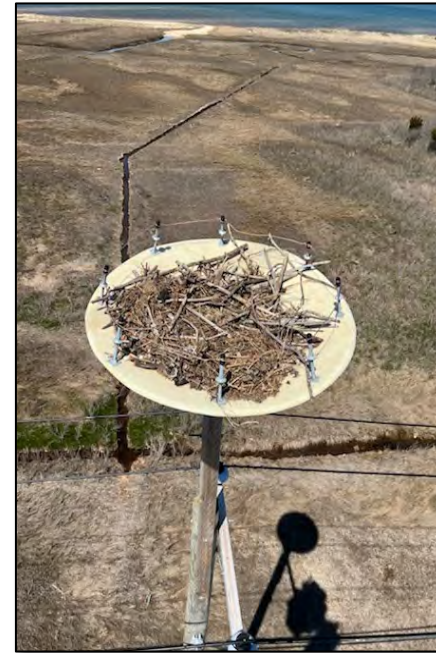
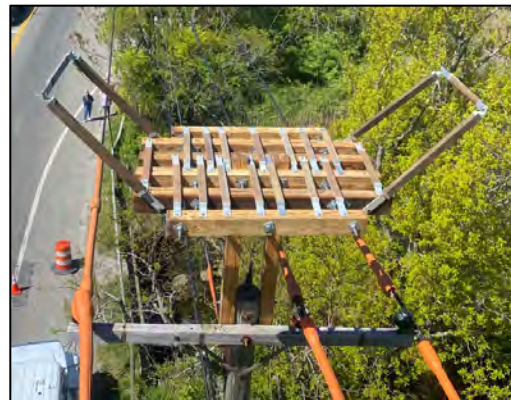
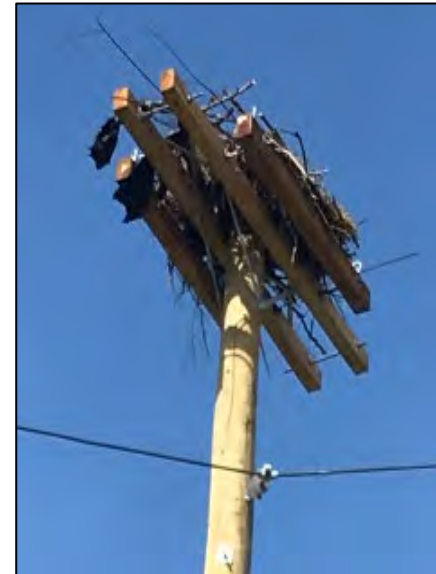
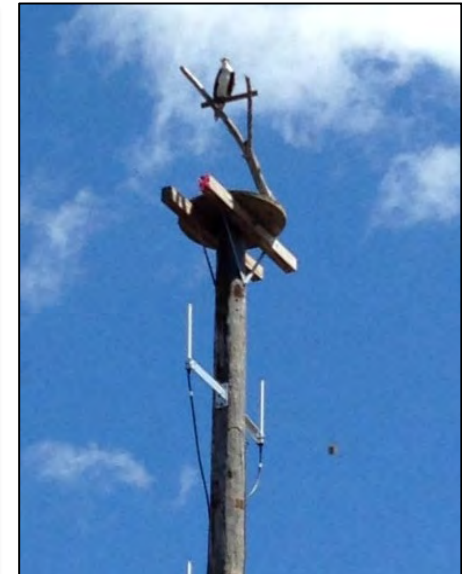
Distribution – Osprey Nesting

Osprey nest relocation and platforms to provide safer nesting options.

- Alternate nest poles – not always feasible
- Nest platforms above energized components
- Opportunity for nest cams

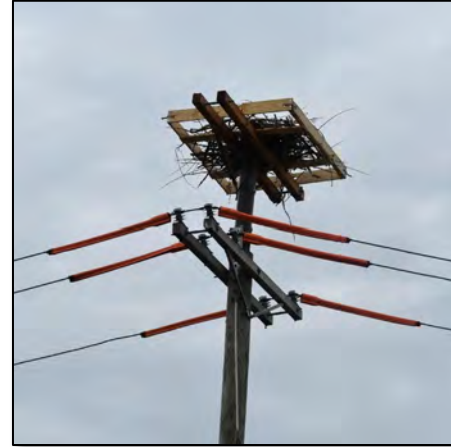
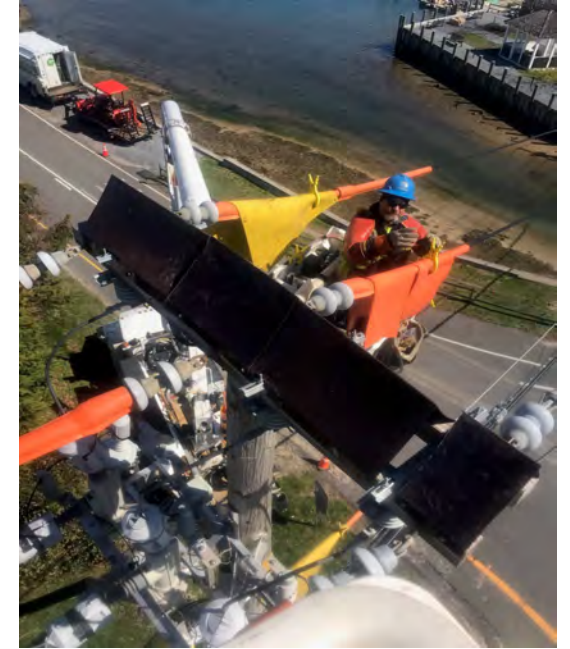
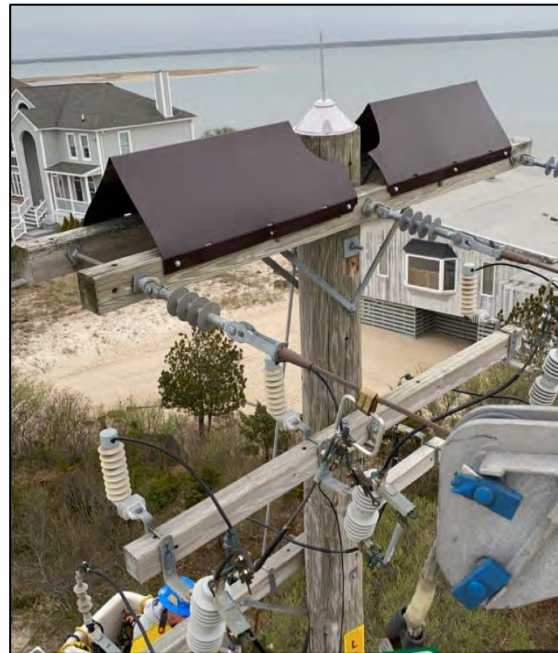
Distribution – Osprey Nesting

Retrofit poles in high avian use areas to minimize collision and electrocution risk.

- Tool Box
 - Perch/nest deterrents (V - Guards)
 - Single cross arms
 - Pole caps
 - Line & Insulator covers
 - Bird diverters
- Location, construction and species specific

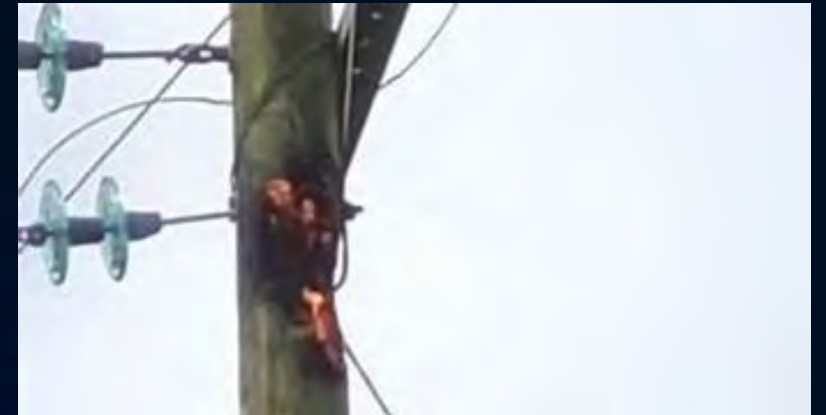
PD Current Characteristics

- Normal Leakage Current is Capacitive in Nature and Low level
- Capacitive Currents typically are less than 4 mA
- Currents Generated During Surface PD are Resistive in Nature
- Surface PD Currents Can Exceed 500 mA
- Continuous Currents of More Than 10 mA Have Been Shown to Initiate Pole Fires

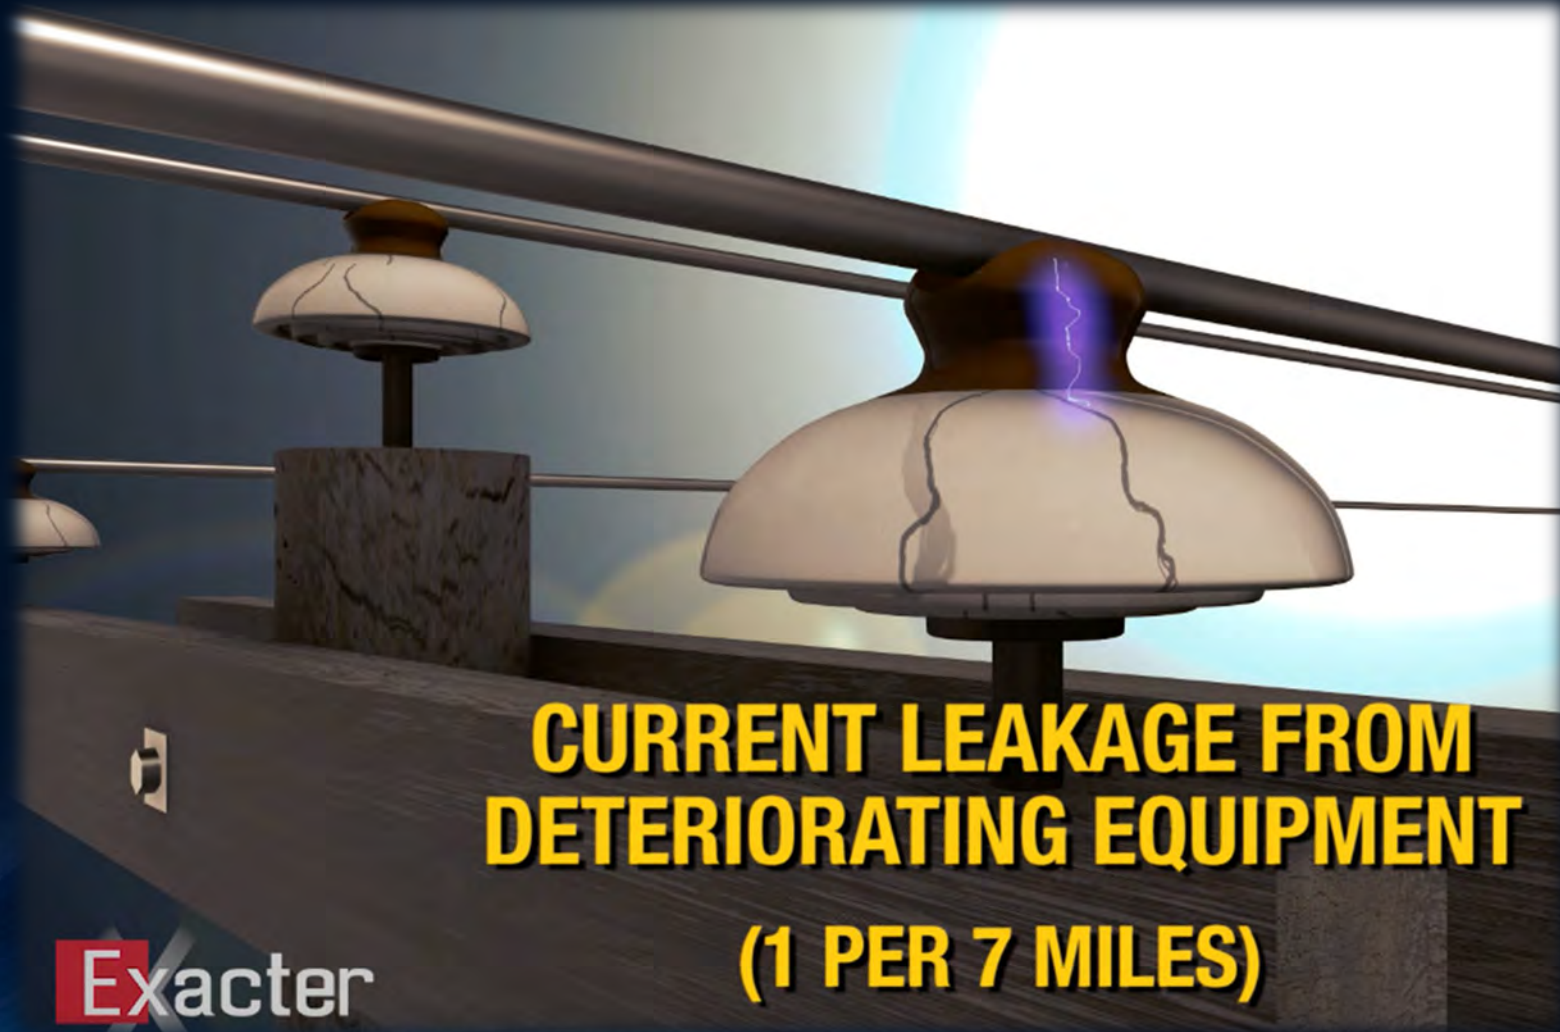
Pole Fire Process

**CURRENT LEAKAGE FROM
DETERIORATING EQUIPMENT**

(1 PER 7 MILES)

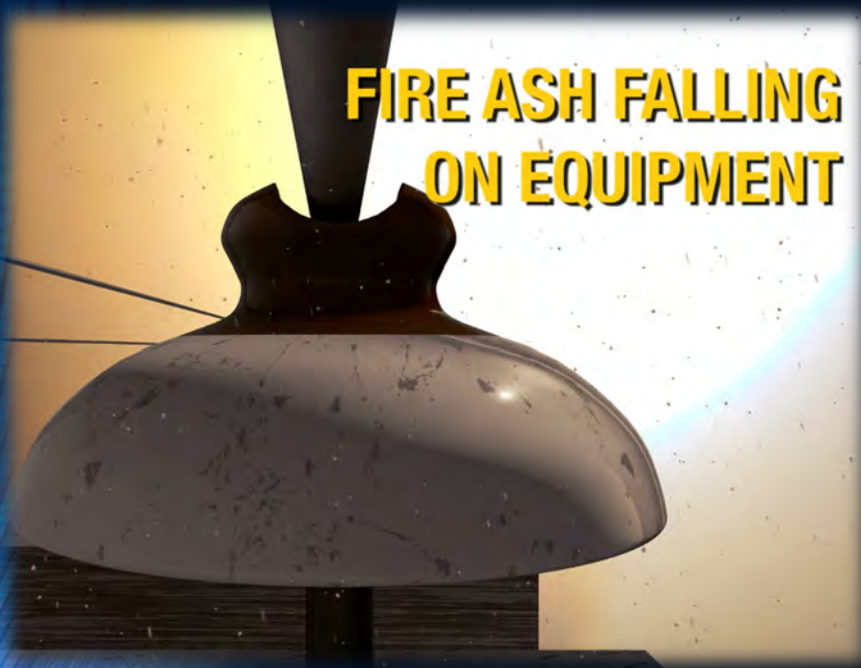
**FIRE ASH FALLING
ON EQUIPMENT**

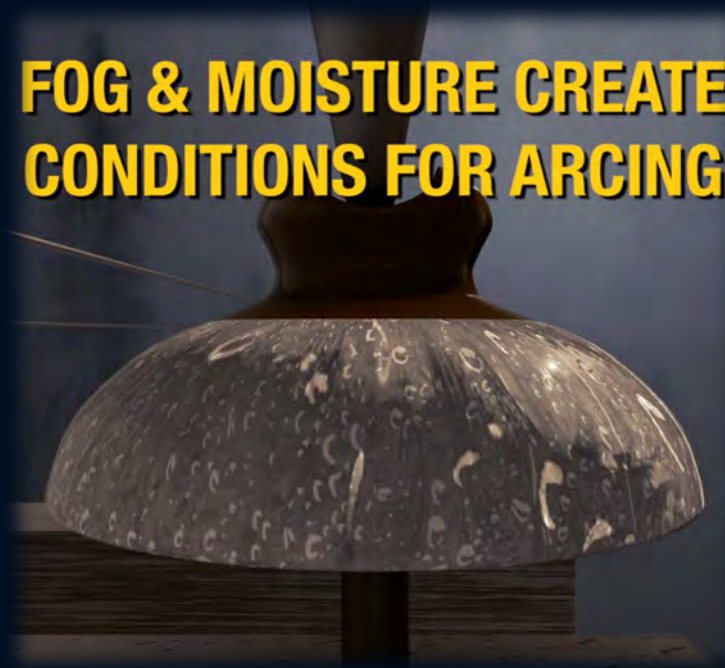
**FOG & MOISTURE CREATE
CONDITIONS FOR ARCING**

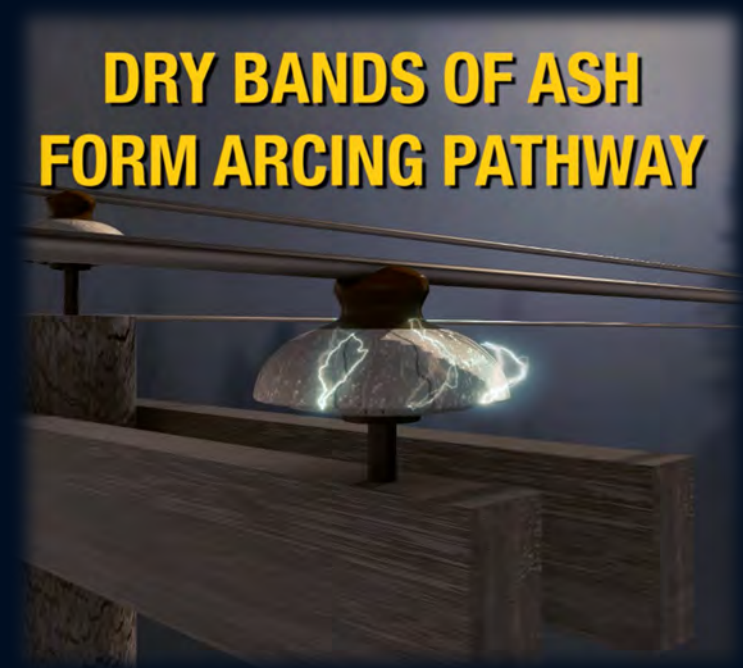
**DRY BANDS OF ASH
FORM ARCING PATHWAY**

**WHEN MOISTURE RETURNS,
DRY BANDS PROVIDE ARCING PATHWAY**

- Diverged axial currents will cause the growth of the dry layer across the flow of current lines and the dry band is formed
- Most of the applied voltage appears across the dry band
- At a critical value, surface partial discharges appear across this dry band
- This surface partial discharge is called Scintillation

- Typical leakage current is capacitive and low level
- Scintillation shortens the creepage length and resistive leakage current increases dynamically
- Increased resistive leakage current leads to formation of another dry band and increased Scintillation
- If the number of scintillations at a given time crosses a critical number, then flashover occurs

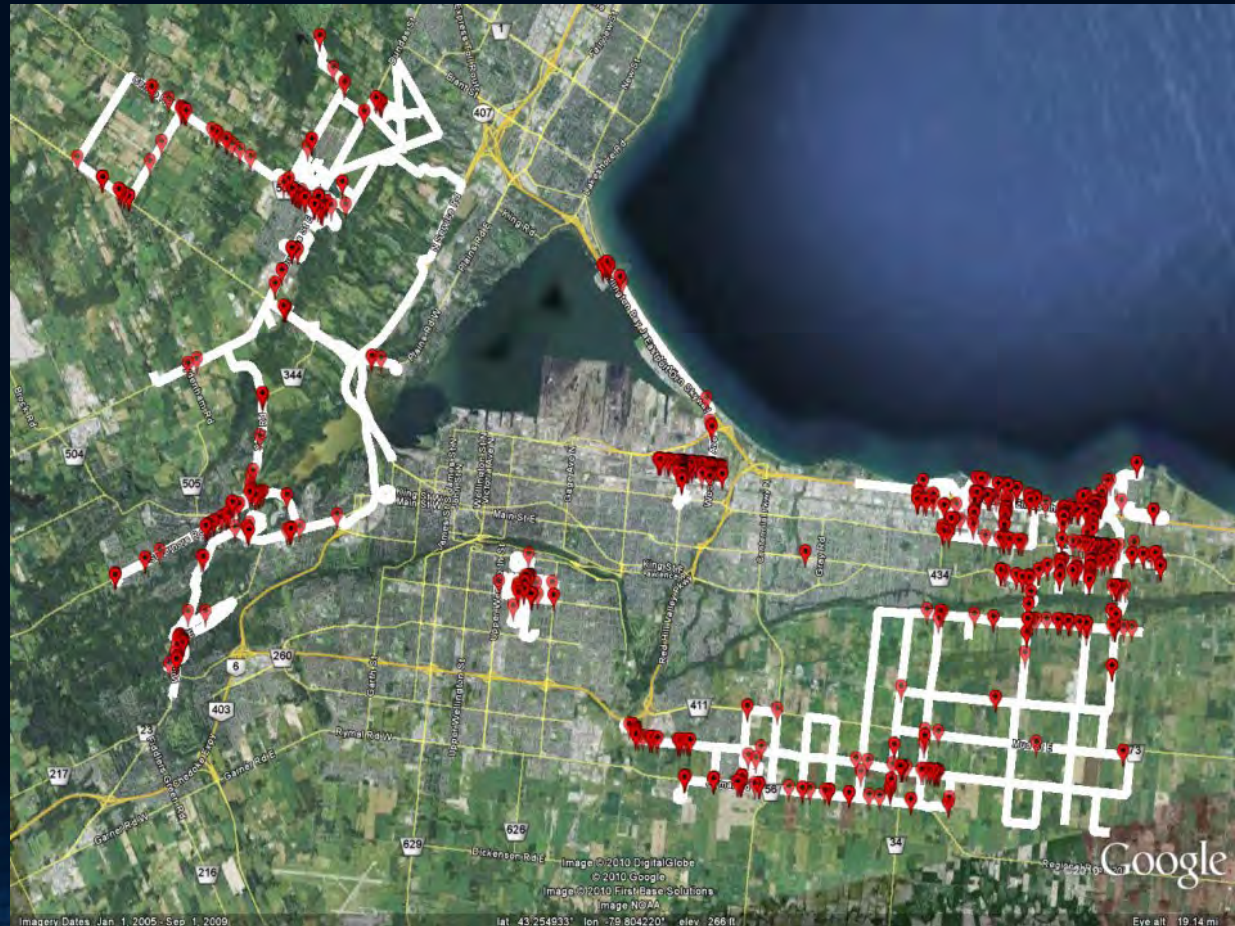
Condition Assessment: EXACTER Condition Assessment Results

The **986 RED** Failure Signature Events are studied by EXACTER Servers to create this result: **25 Blue** Maintenance Groups where a structure includes at least one deteriorated component.

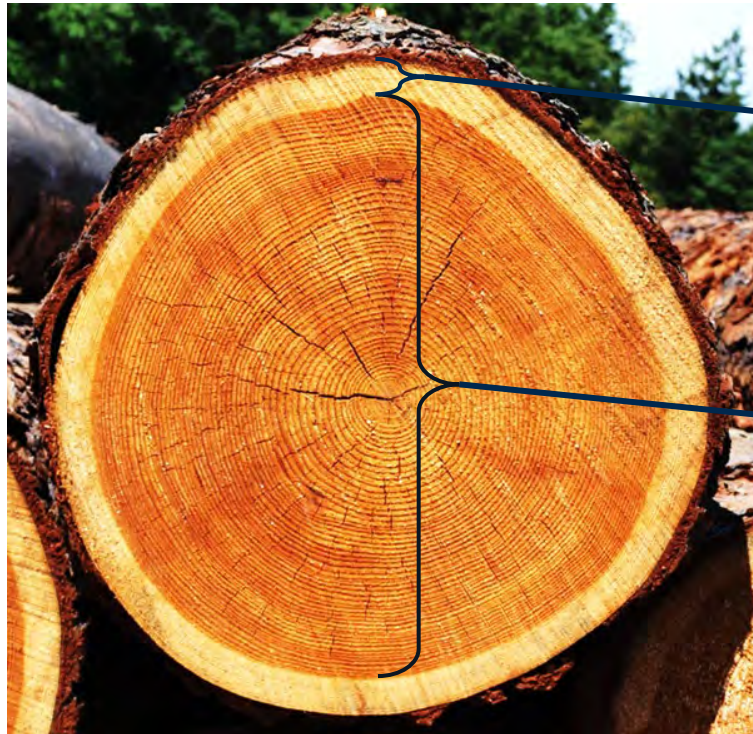
Red Pine

Northern Pine

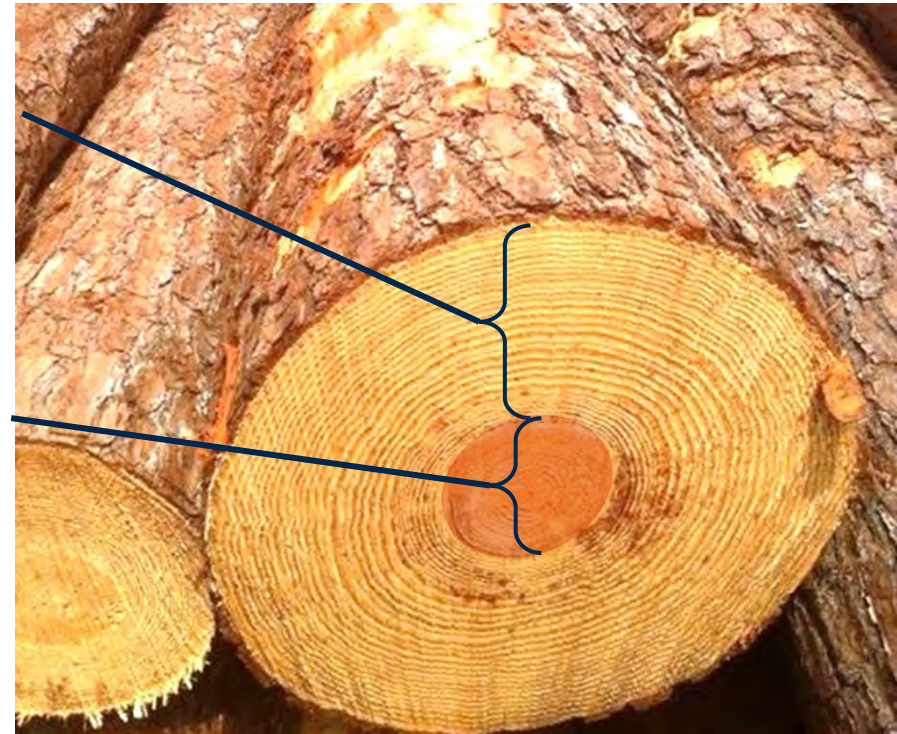
Douglas-fir

Sapwood

Heartwood

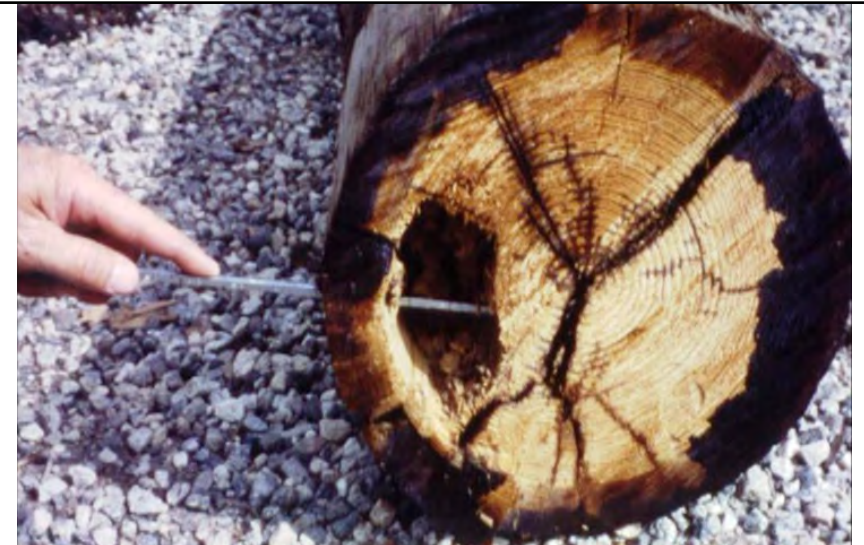
Wood Anatomy | Species Characteristics

- Thick Sapwood
 - ~75% of assessed poles assessed annually
 - 3.6m assessed in 2023
 - Typically decays from the **outside-in**
 - Shell Rot
- Thin Sapwood
 - ~25% of poles assessed annually
 - 1m assessed in 2023
 - Typically decays from the **inside-out**
 - Enclosed Pockets
 - Hollow Poles

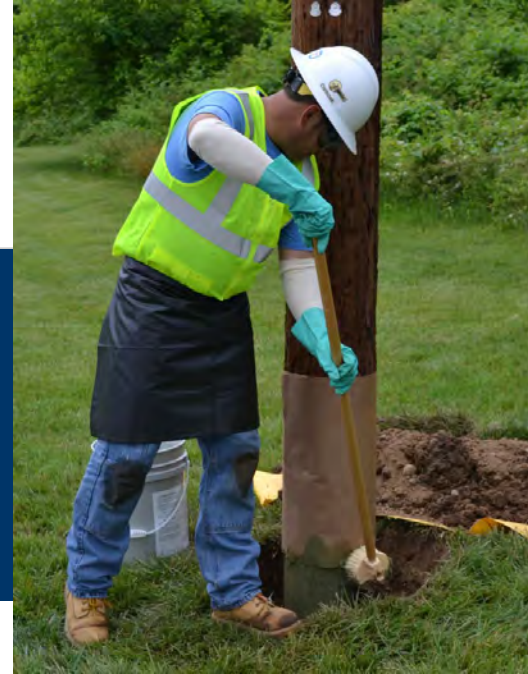
18 STEPS OF INSPECTION

Background | Full Excavate

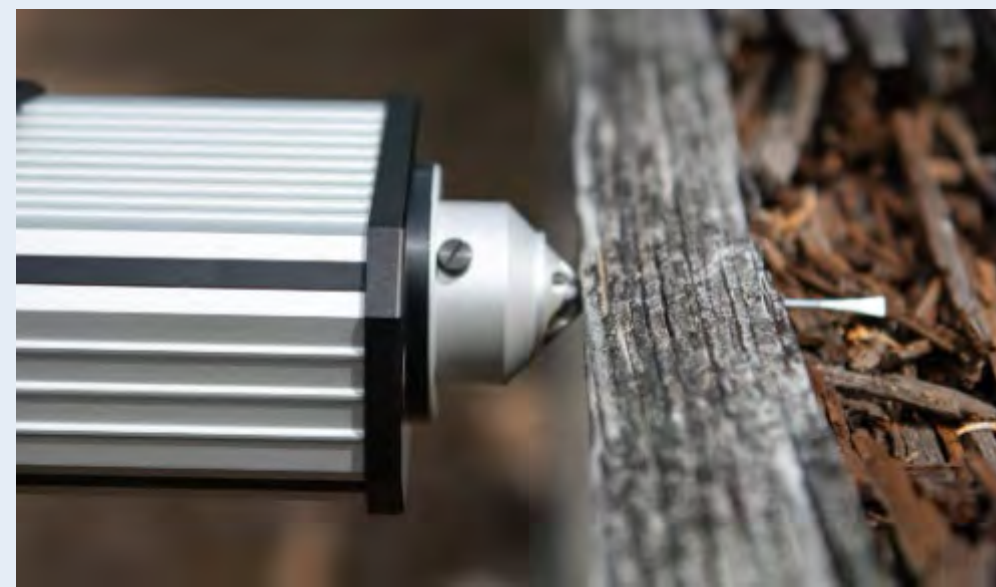
Background | Resistance Drill

Engineered tool requiring routine maintenance & calibration

20-50 *Poles before needle replacement*

- Good option for poles in concrete

- Cannot identify external decay
- Frequent & expensive repairs
- Little-to-no life extension (fumigants)

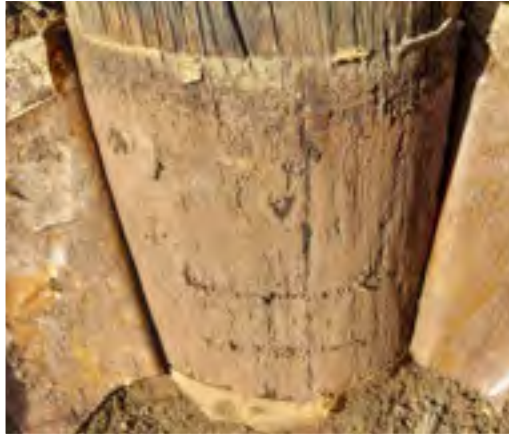
No Decay

no observable decay identified for a given assessment method

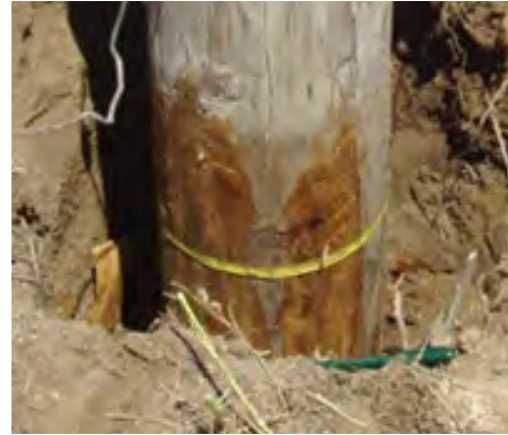
Decayed but Serviceable (DBS)

Measurable decay that is determined to have a remaining strength of MORE than 67%

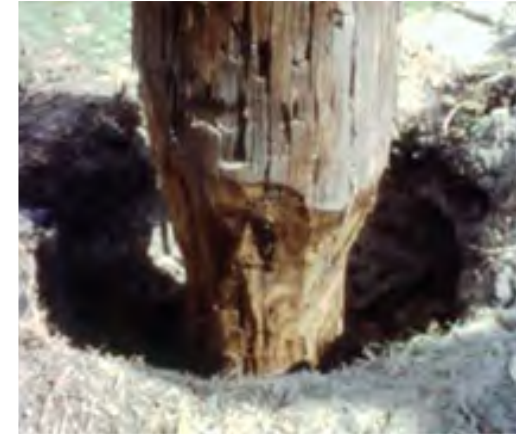
Reject

Measurable decay that is determined to have a remaining strength of Less than 67%

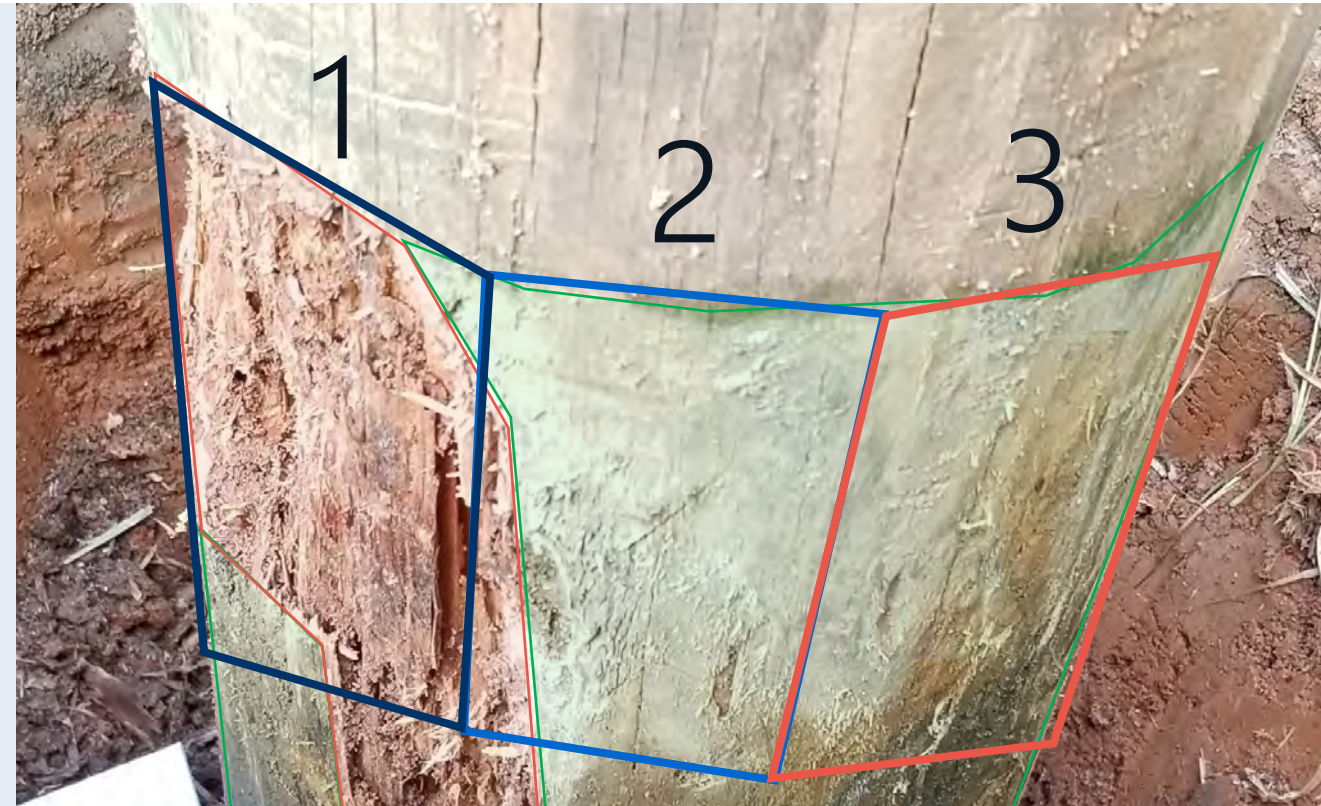
Sufficient decay found to identify reject with either process

Non-condition based partial process would only identify some decay. Could not identify as a reject without condition-based process

No decay identified in excavated location

Partial	Non-Condition-Based	Condition-Based
Location 1	Reject	Reject
Location 2	DBS	Reject
Location 3	No Decay	No Decay

- **Non-Condition-Based (NCB) Assessment:** make a pole condition determination based only on the partial assessment specified.
- **Condition-Based (CB) Assessment:** upon identifying decay during the partial, a full excavation is performed to identify and measure the decay below groundline

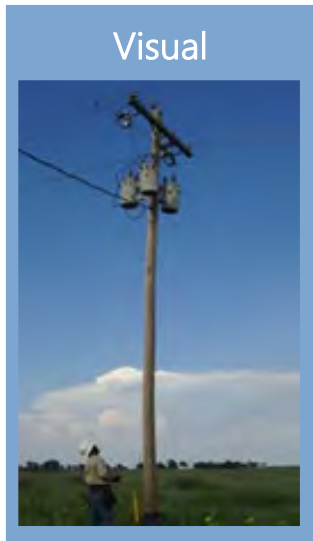
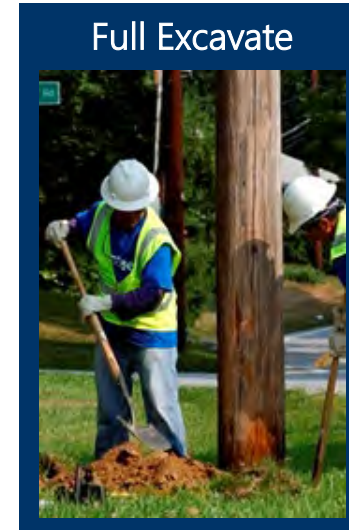
Procedure | Assessment Method

Crew 1 Methods tested individually

Crew 2
Full Excavate
Assessment
