EDM

Evaluating the Effectiveness of the TransGard Laser System at Substations in Indiana and Louisiana

Ashley Bennett, PhD, EPRI
James Dwyer, PhD, EDM International
Rick Harness, EDM International
Yamille del Valle, PhD, EPRI
American Electric Power
Entergy

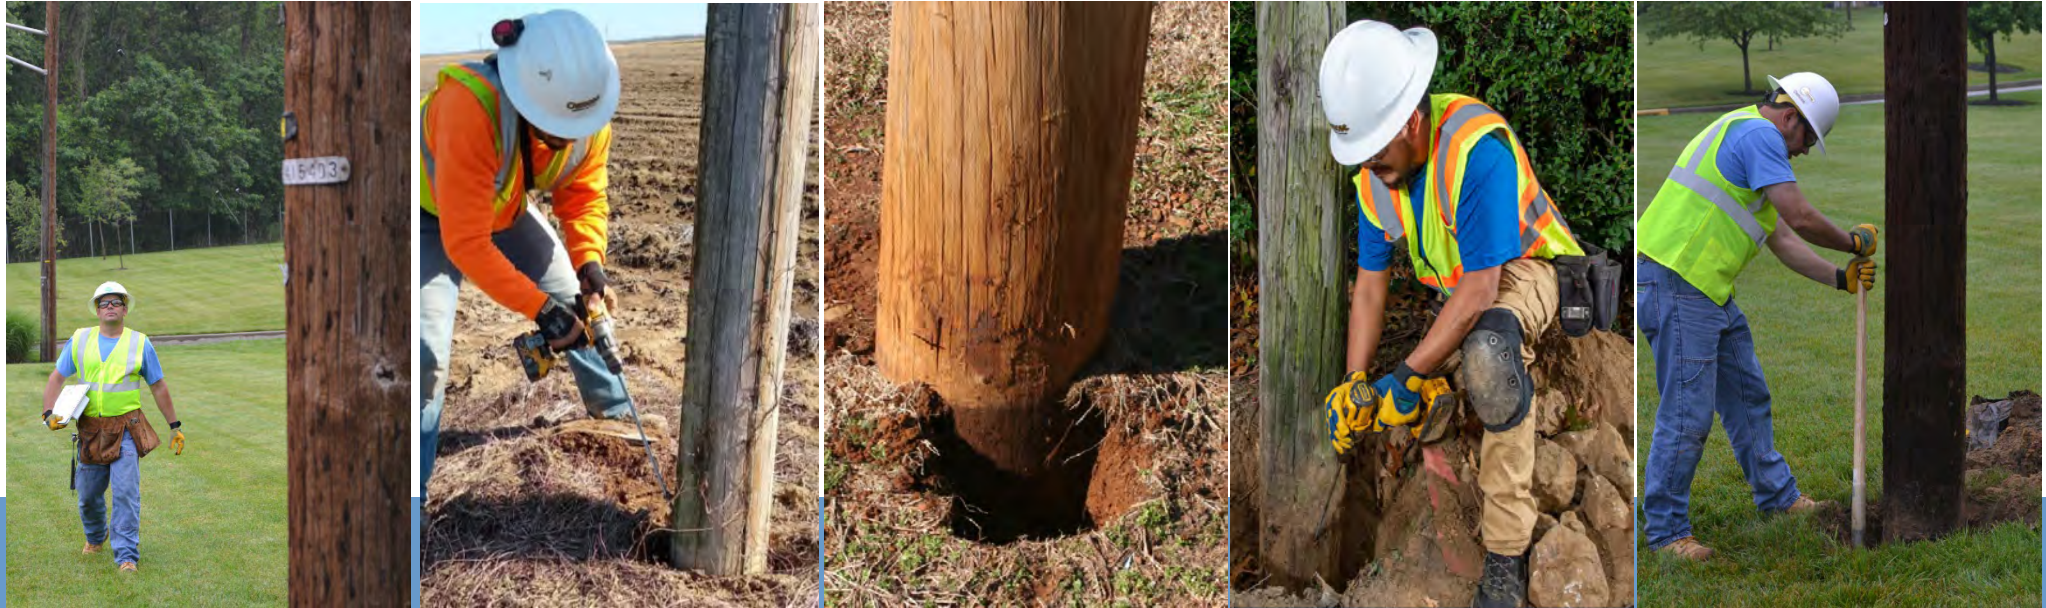
Results | Comparison Summary

Assessment Type	Thick Sapwood Reject Effectiveness	Thin Sapwood Reject Effectiveness
Full Excavate	98%	98%
Partial (Conditioned-based)	73%	96%
Partial (Non-Conditioned)	30%	72%
Sound & Resistance Drill	25%	35%
Sound & Bore	17%	47%
Visual	6%	8%

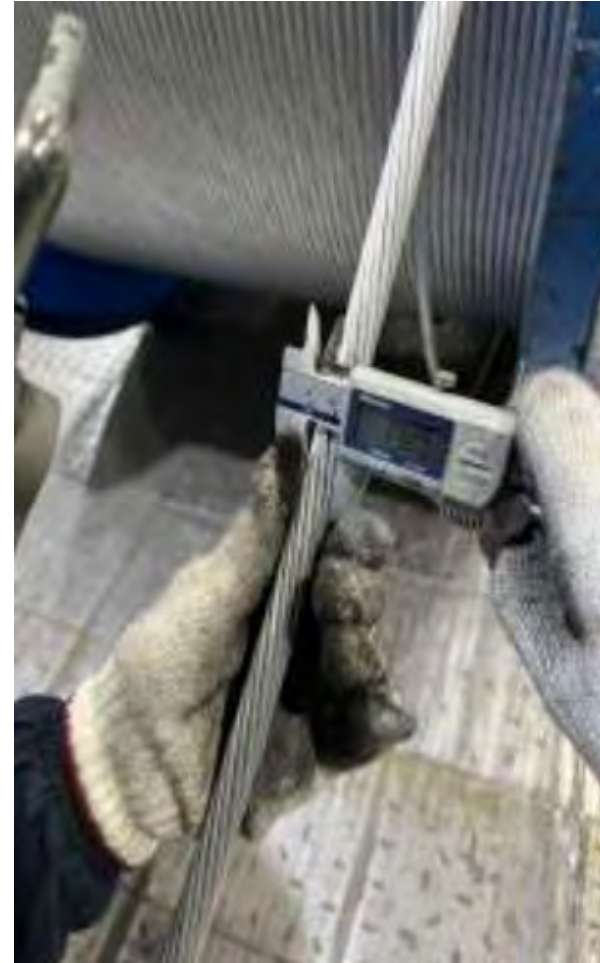
checking diameter

- **ASTM A363 Steel Overhead Ground Wire Strand**
 - Breaking Strength and Elongation
 - Ductility
 - Adherence of Coating
 - Diameter and Finish
 - Stranding direction and Lay Length

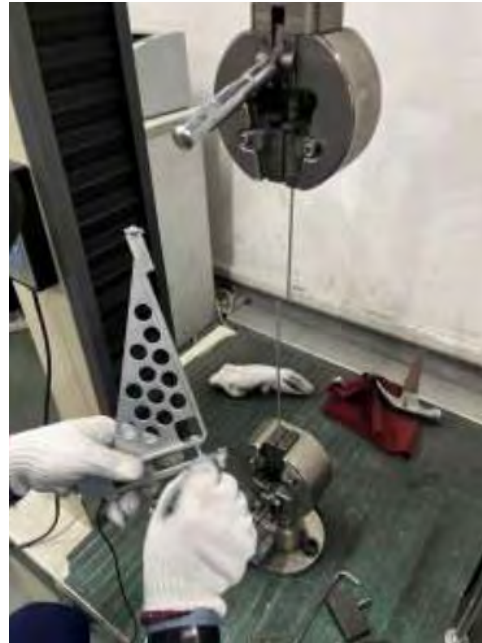
Tensile and Elongation testing

- Tensile
- Elongation at failure
- Diameter
- Resistance
- Zinc coating thickness (for steel wires)
- Twist test for steel wires
- Bending test for Aluminum wires

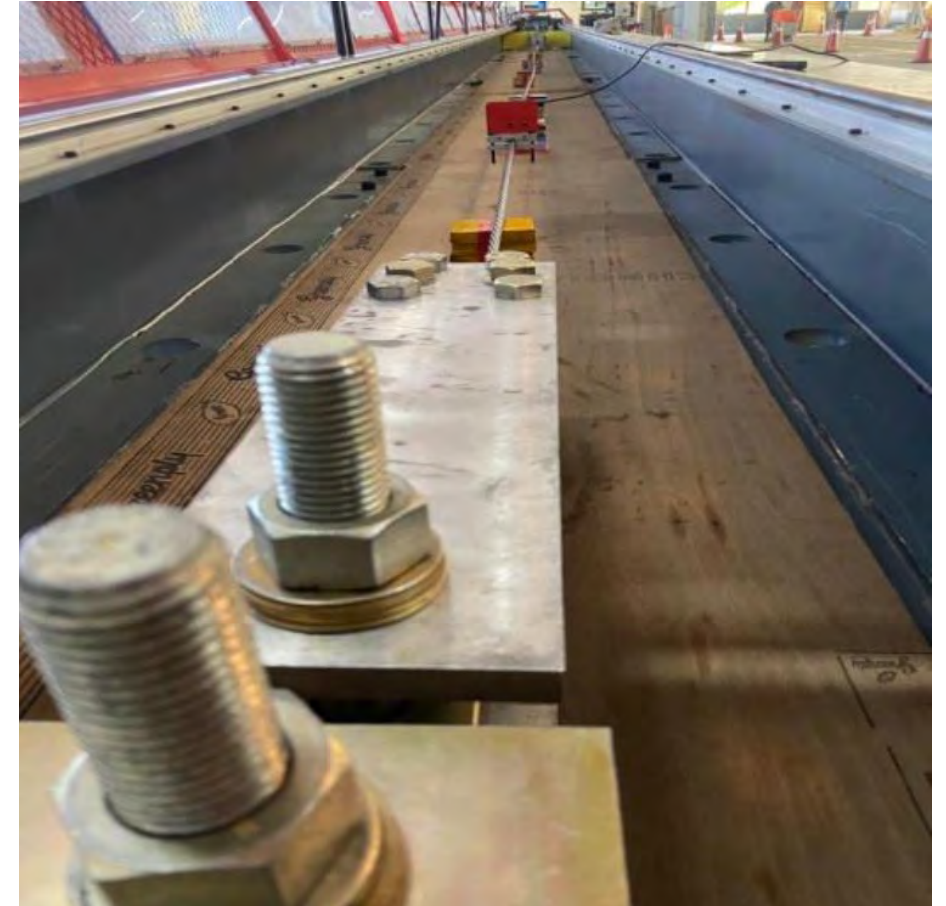
View along a tensile test bed.

- Determination of **Load Stretch** behavioural polynomial parameters

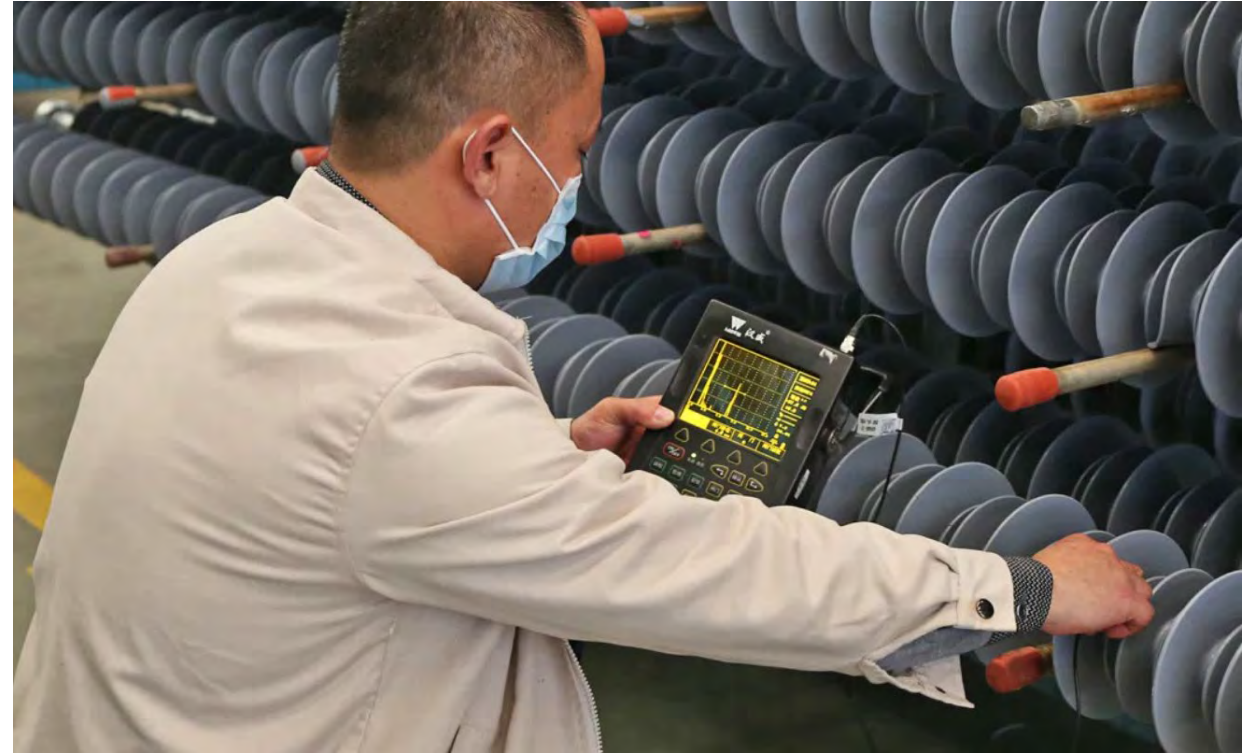
Composite Insulators

- **ANSI C29.12 Transmission Line Composite Insulators**
 - Interfaces and Connections of End Fittings
 - Core Time-Load
 - House Tracking and Erosion
 - Dye Penetration
 - Water Diffusion
 - Flammability
 - Low-Frequency Dry Flashover
 - Low-Frequency Wet Flashover
 - Critical Impulse Flashover (+ve & -ve)
 - Radio-Influence Voltage (RIV)

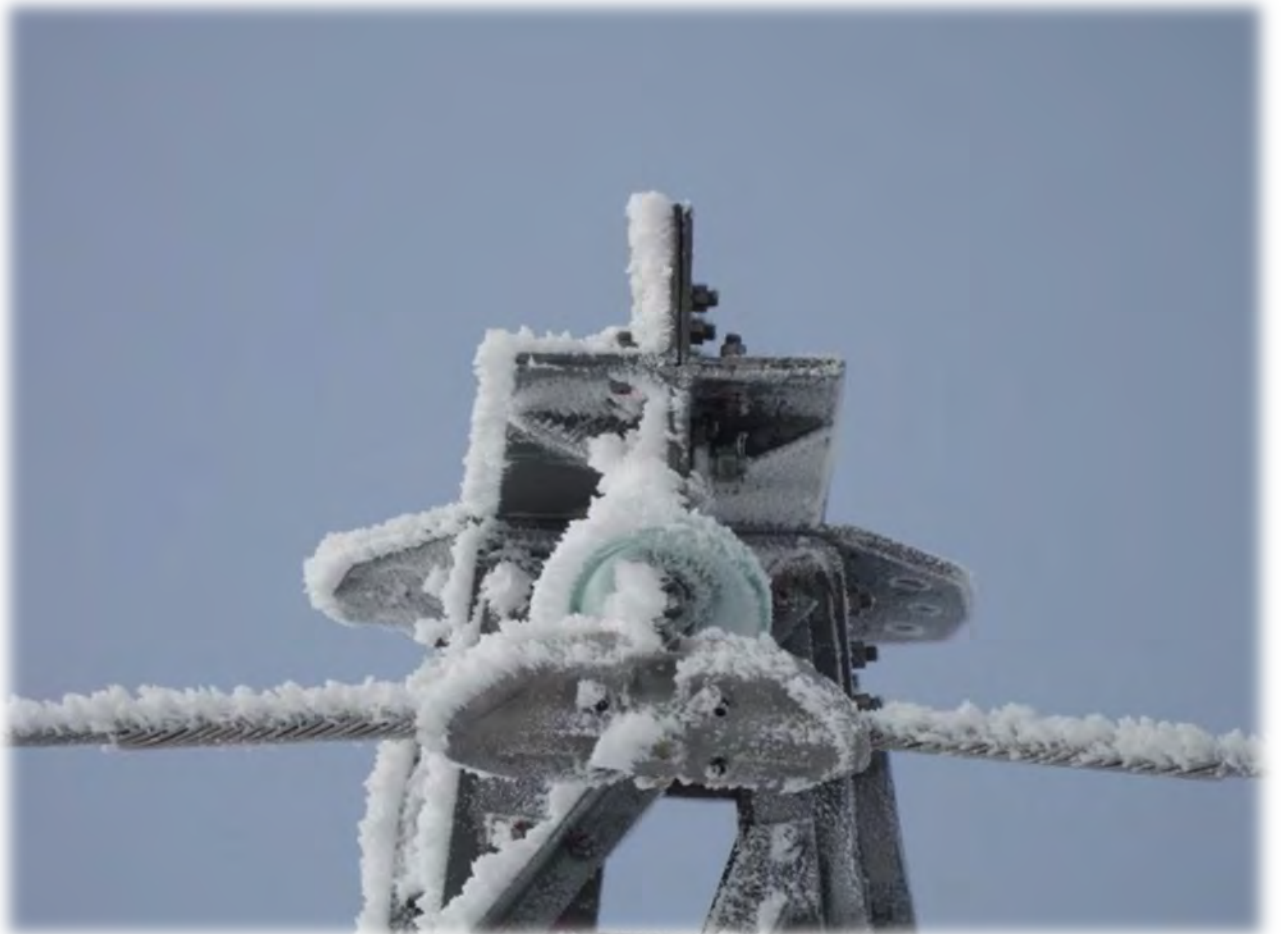
Suspension Clamps

- **IEC 61284 Overhead Lines requirements and tests for fittings**
 - Ultimate Strength
 - Slip Strength
 - Clamp Bolt Tightening
 - Dimensional and Material
 - Visual
 - Clamp bolt tightening
- **ASTM A153 Hot Dip Zinc Coating on Iron and Steel Hardware**
 - Galvanising
- **ASTM A370 Materials Testing**
 - Charpy test

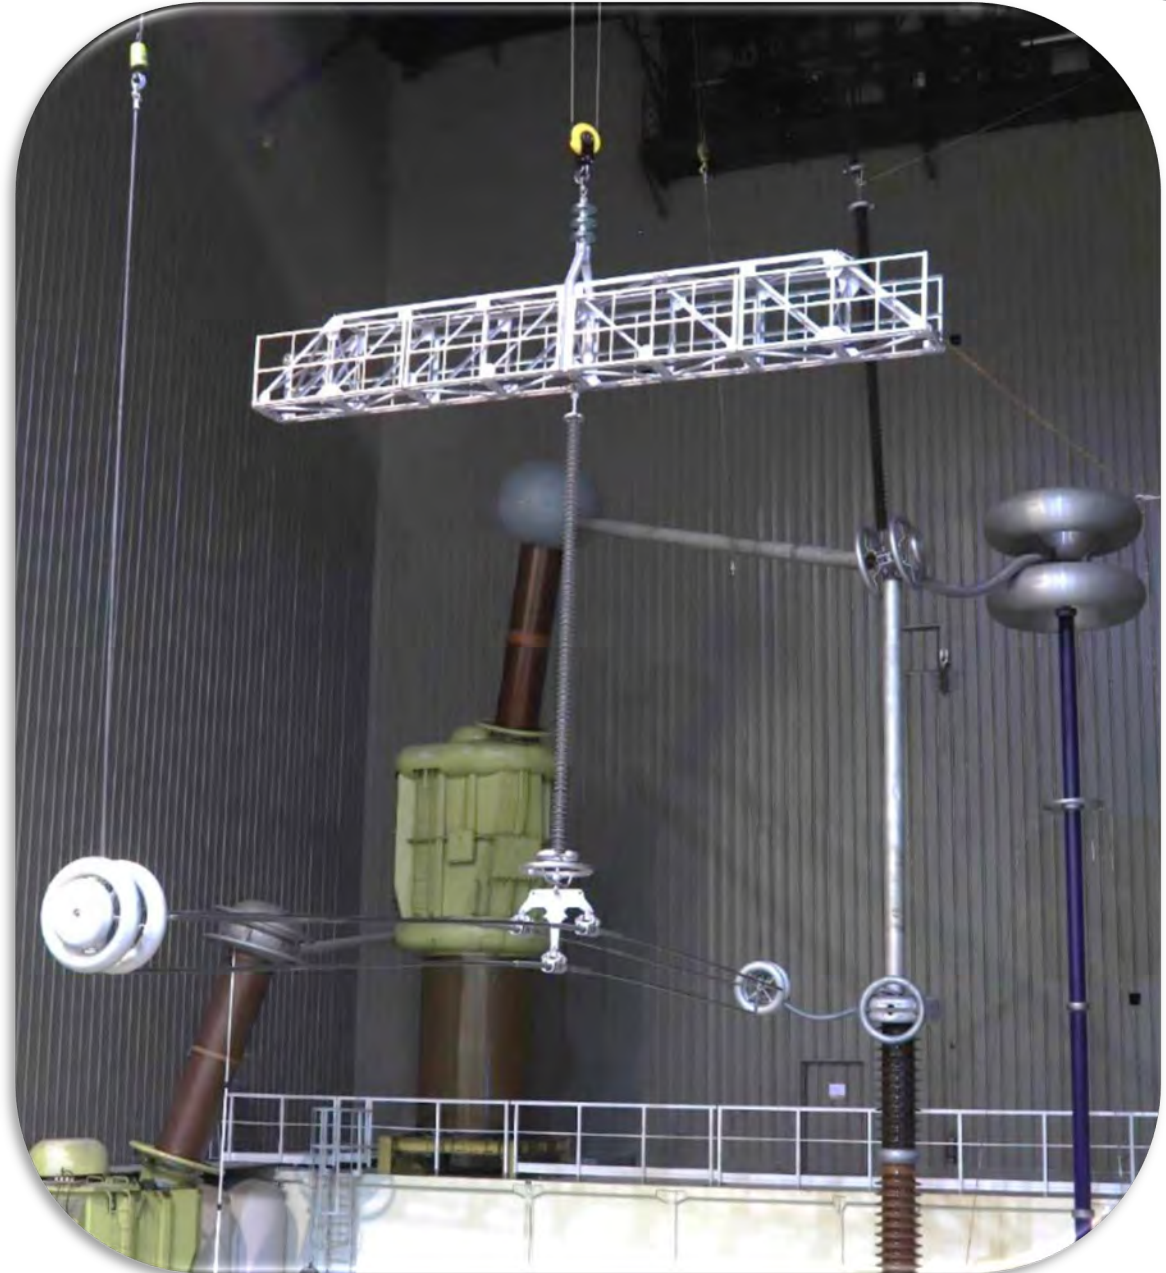
Complete Assemblies

- **IEC 61284 Overhead Lines requirements and tests for fittings**
 - Corona and RIV
- **IEEE 1829 Corona Tests on Hardware for Overhead Transmission Lines**
 - Corona and RIV

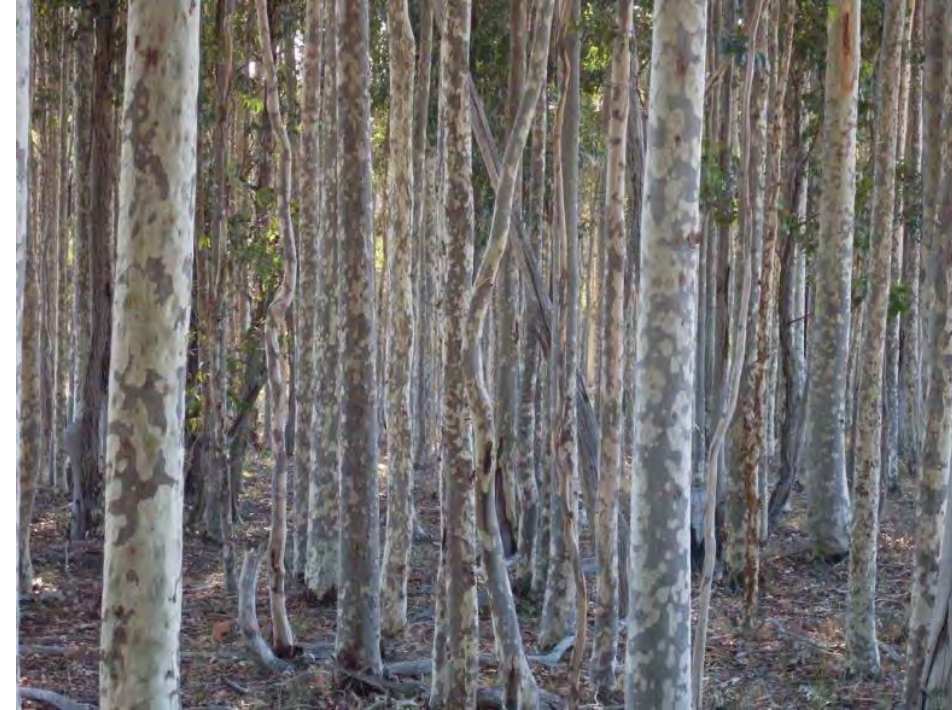
Australian Spotted Gum (Hardwood)

- Heartwood ranges from pale to dark brown with characteristic dark streaks or spots.
- Moderately coarse and often interlocked grain.
- Exceptionally durable (Durability Class 2).
- Strong and robust, resistant to impact and wear.
- Many hardwoods are denser than softwoods and have a more complex cell structure
- Applications in household, utility poles etc.

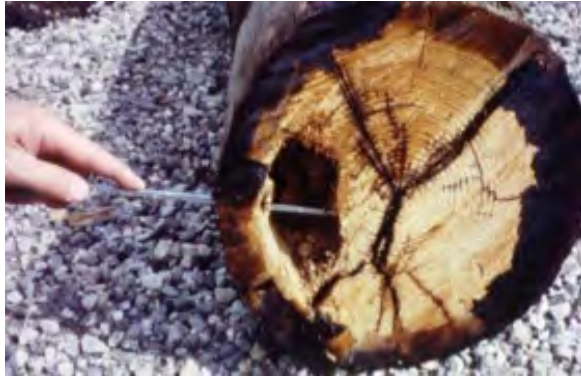
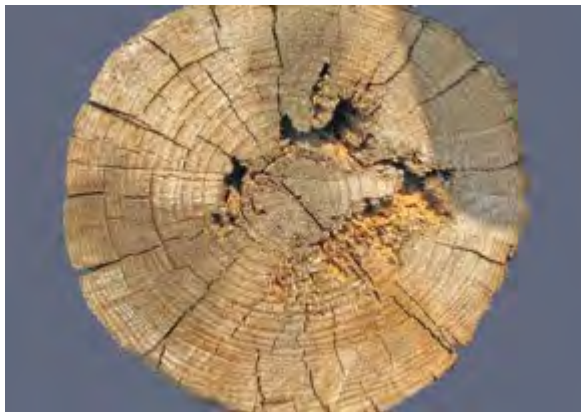
Decay Pockets

**images are not of spotted gum species, but rather used to illustrate decay/insect damage types*

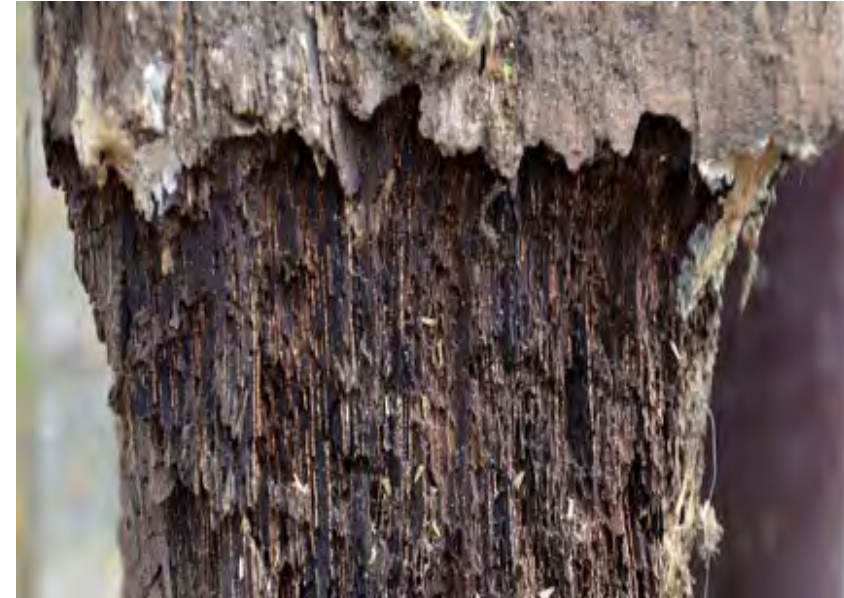
External decay

- Spotted gum generally resistant to decay compared to softwood, however, not entirely resistant to decay
- Timber decay, including that of spotted gum, is a significant issue in the timber industry worldwide.
- Regular inspection and treatment can mitigate or slow down the decay.

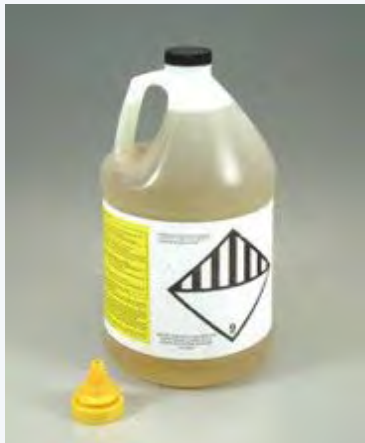
Metam Sodium (liquid)

- Liquid – pours easily
- Decomposes to ~18% MITC
- NOT moisture dependent

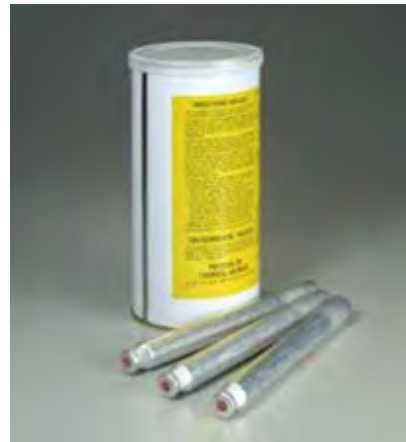
MITC (solid melt)

- Pre-measured dose
- Sealed aluminum tubes
- MITC as active, >97%
- Not moisture dependent

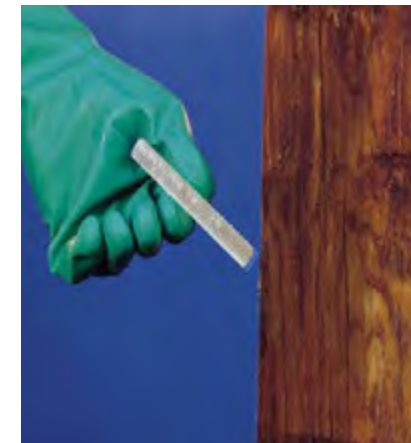
Boron Rods

- Pre-measured dose, ease of application
- Require moisture to solubilize
- Takes 2-3 years to reach protective levels
- Chances of decay until boron reaches to THF levels

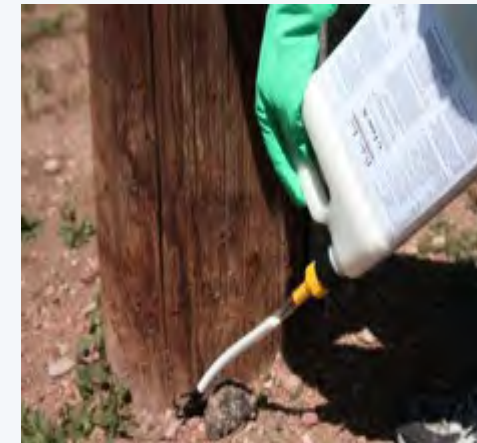
Dazomet (Granular/Compressed sticks)

- ~45% MITC
- Requires moisture
- Copper solutions accelerate decomposition
- Acts immediately

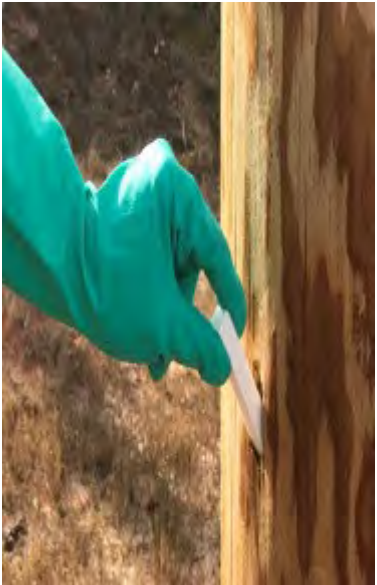
3-Hole Application

Benefits of New Technology-Compressed Sticks

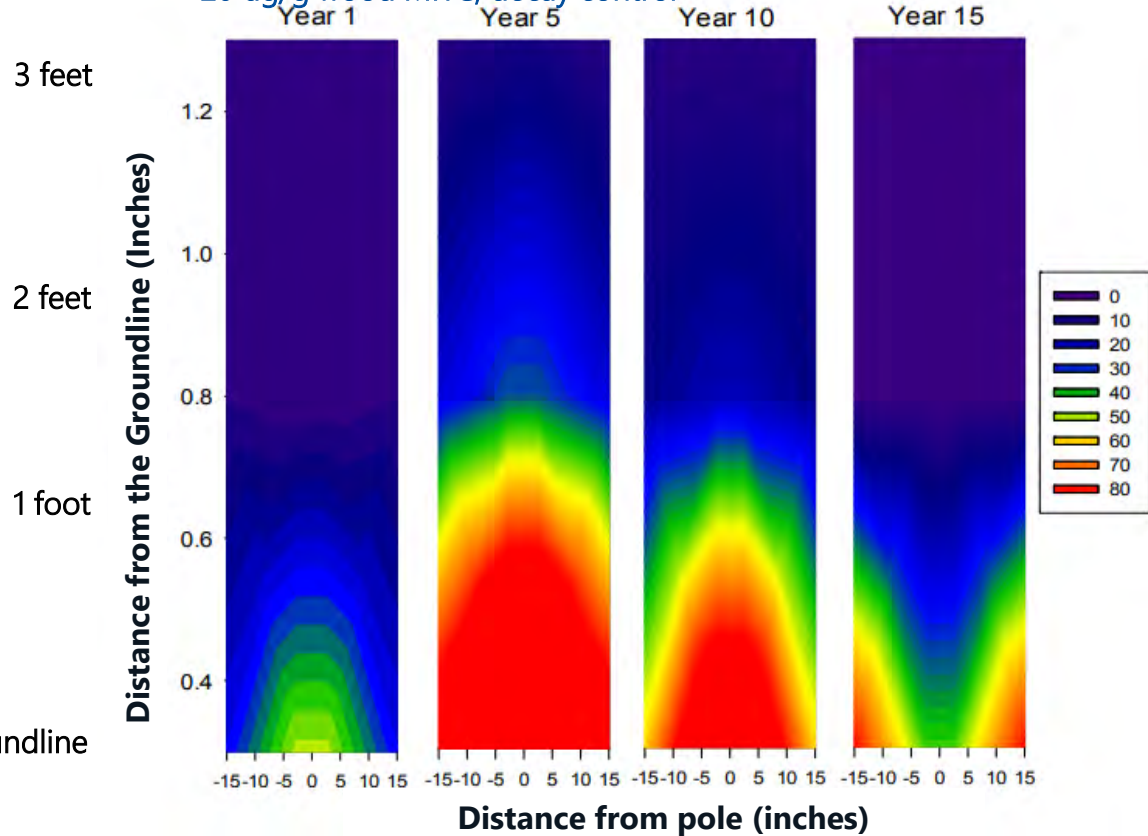
Dazomet Powder+ Cu Solution => MITC Conversion & Movement, 15-Year Exposure - Corvallis, OR

20 ug/g wood MITC, decay control

Oregon State University conducted studies on dazomet and showed efficacy for 15 years with copper accelerant

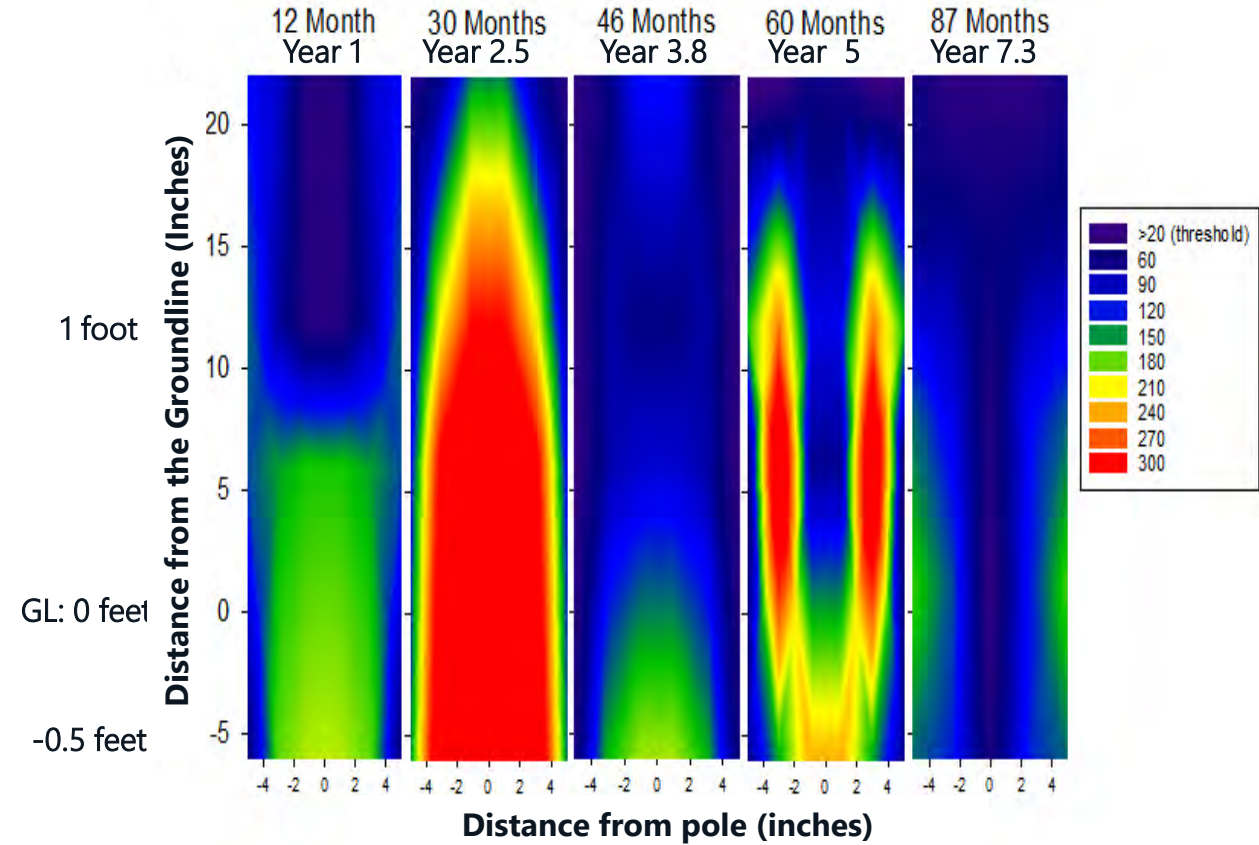
Compressed Dazomet Sticks

Osrose's ongoing studies on compressed dazomet with copper accelerant have shown efficacy for over 7 years.

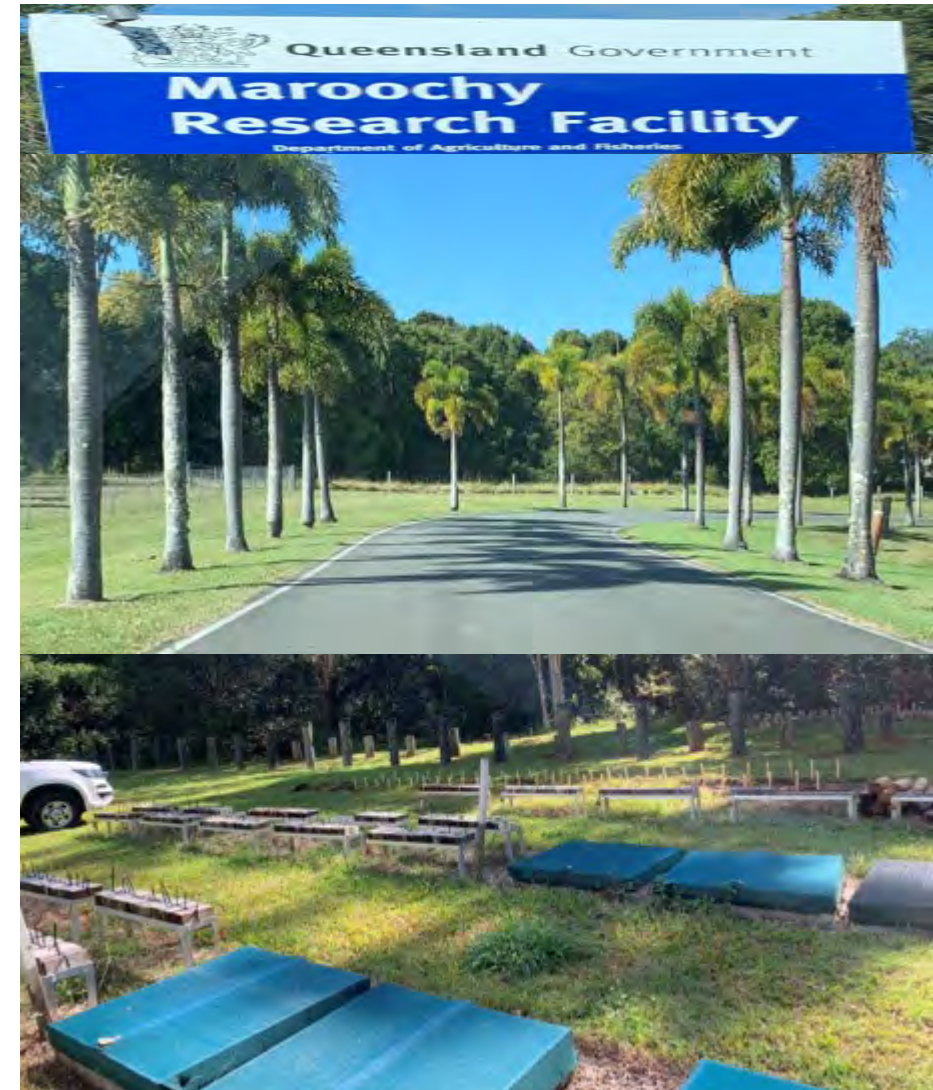
Sites used for testing

1. Central Florida at the Austin Carey Memorial Forest
 - 16 poles untreated Wallaba (*Eperua falcata*)
 - (50-300 mm diameter, 3 m long)
2. The Department of Agriculture and Fisheries (DAF) Maroochy Field Facility in Southeast Queensland, Australia
 - 30 CCA treated spotted Gum (*Corymbia spp.*)
 - 250-300 mm diameter, 2.4 m long

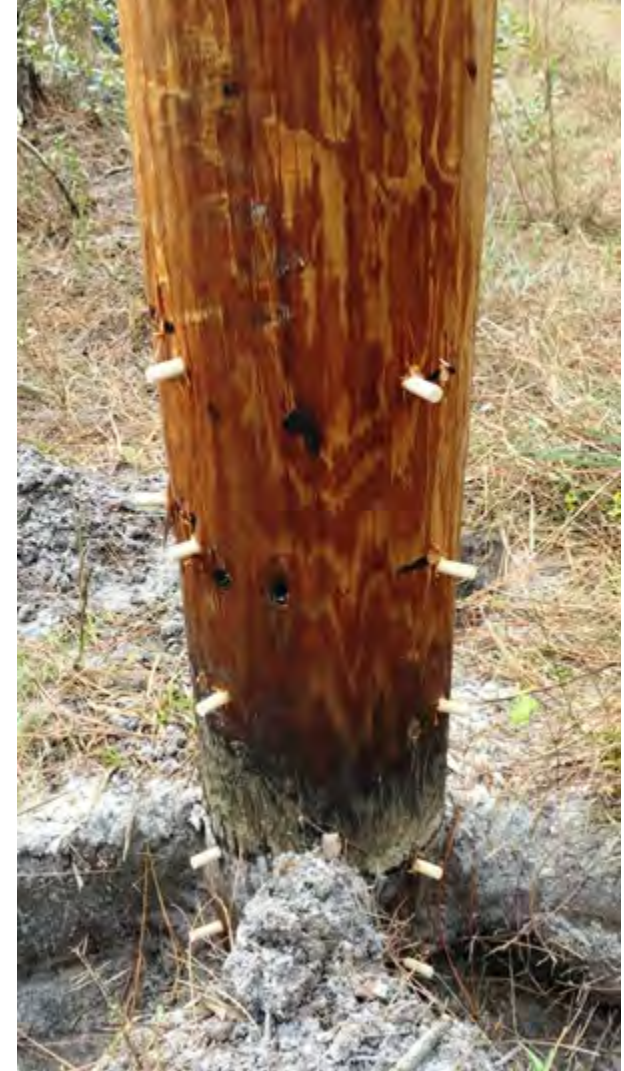
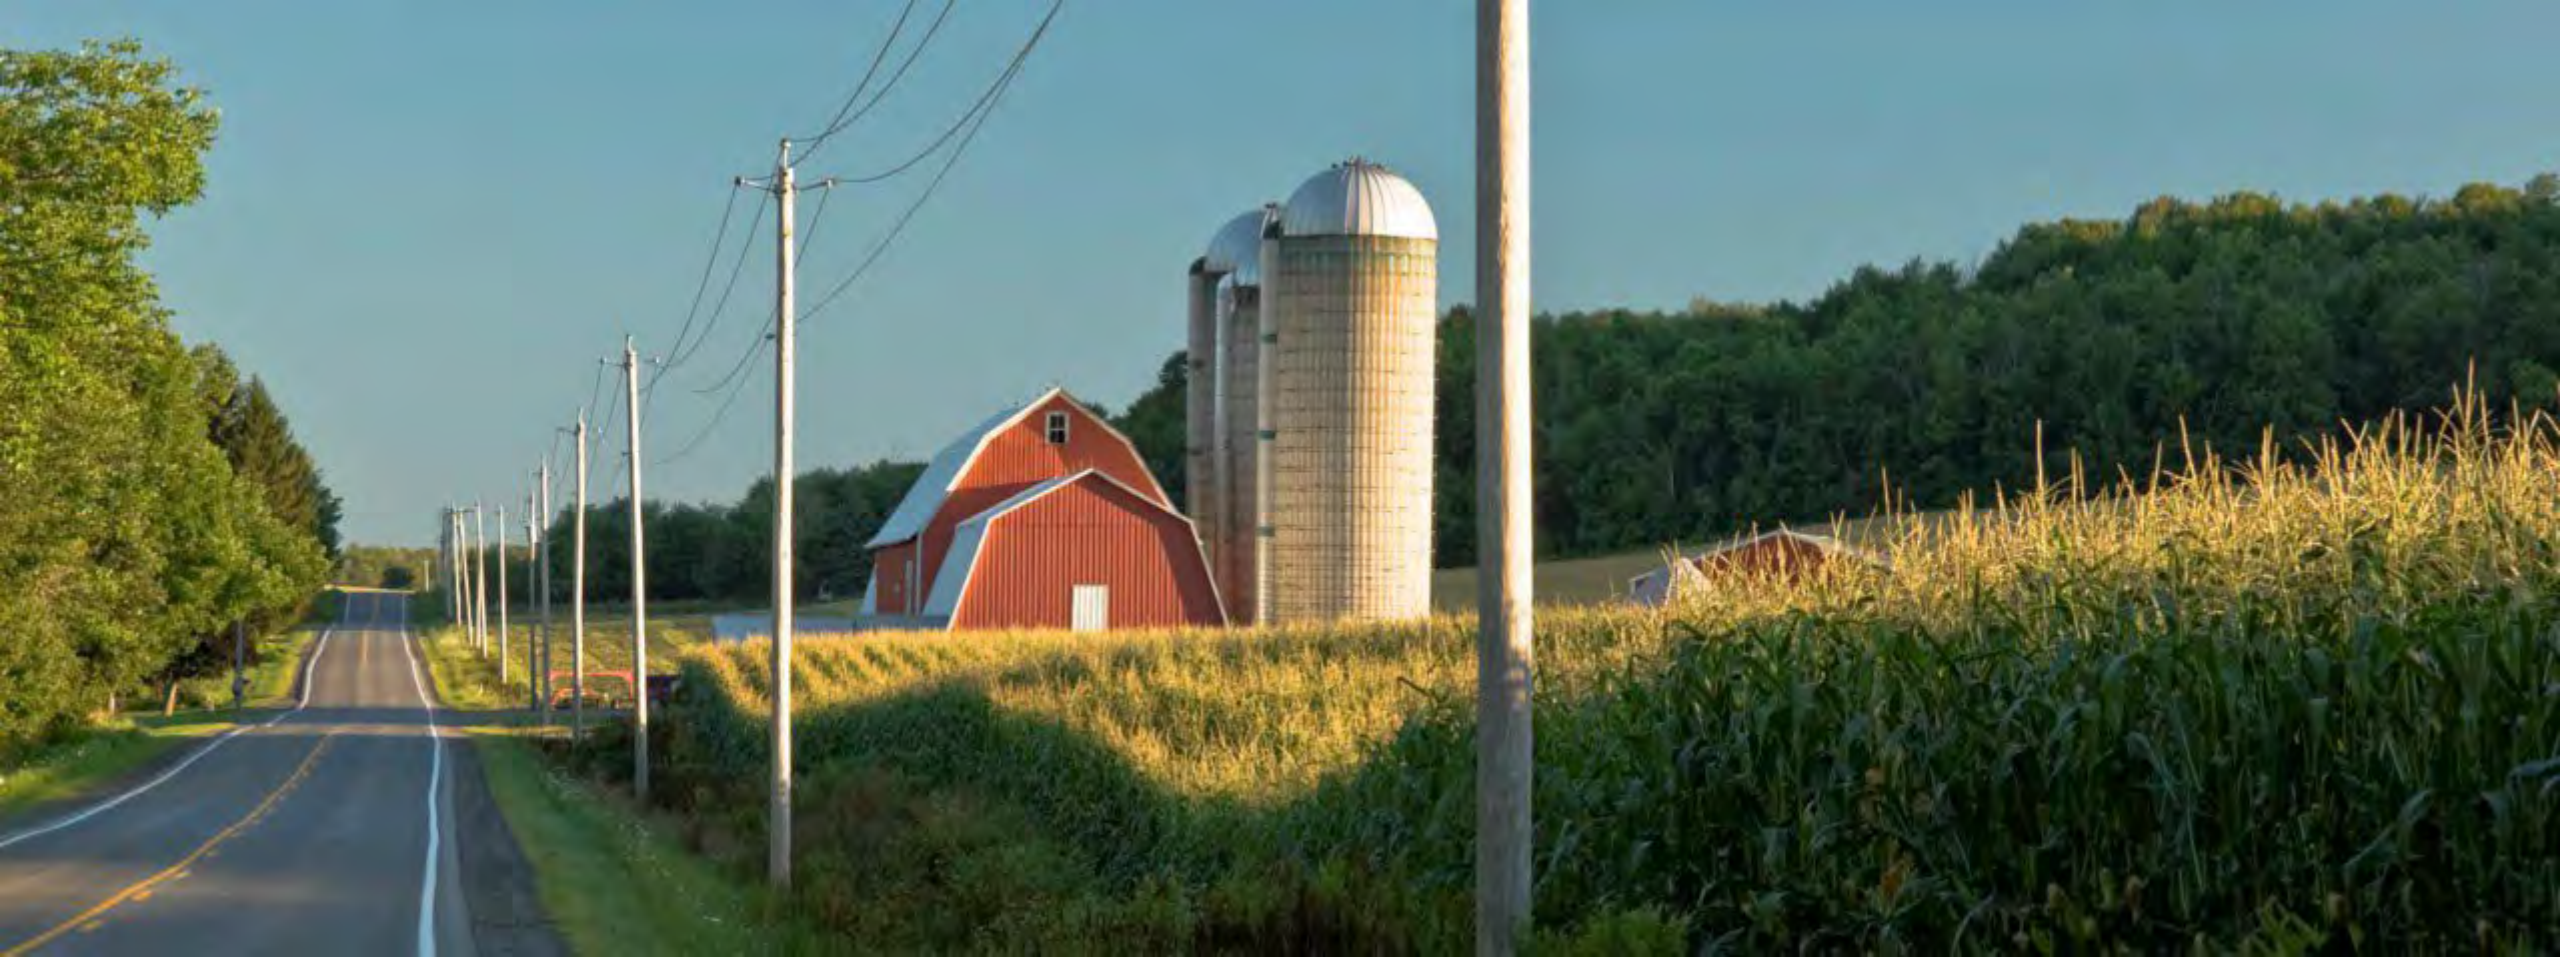
Chemical Analysis

MITC analyzed using Gas Chromatography Mass Spectrophotometer
