Overhead Transmission Structure and Foundation Asset Management – Inspection & Structural Retrofits

Kento Arai (SDG&E®) & Jonathan Jordan, P.E. (EDM International)

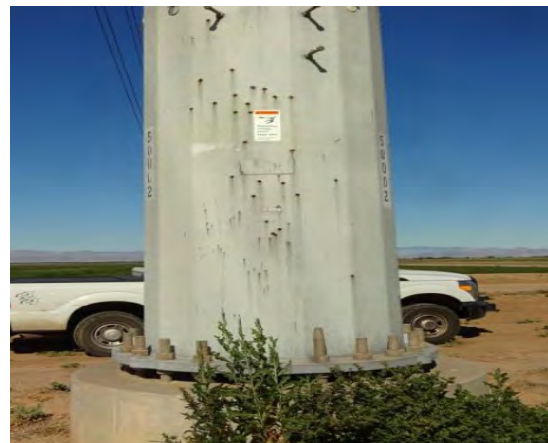
Bullet Holes

7. BULLET HOLE DENTS TO BE REPAIRED USING FIELD PLUG WELDS TO FILL DENTS. DENTS MUST BE FILLED WITH WELD UP TO SURFACE OF POLE AND GROUND SMOOTH ON SURFACE.

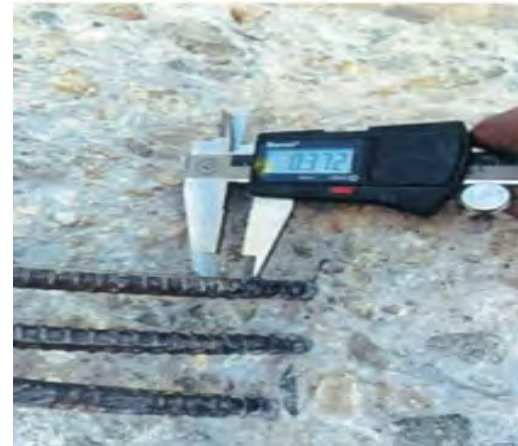
Tie Loss

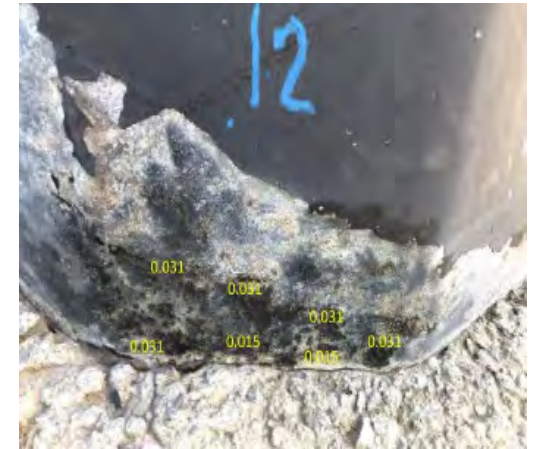
Steel Pitting
